Cuyama Valley Groundwater Basin
Groundwater Sustainability Plan
Groundwater Conditions
Draft

August 2018

Chapter 2 Chapter 2.2 Groundwater Conditions

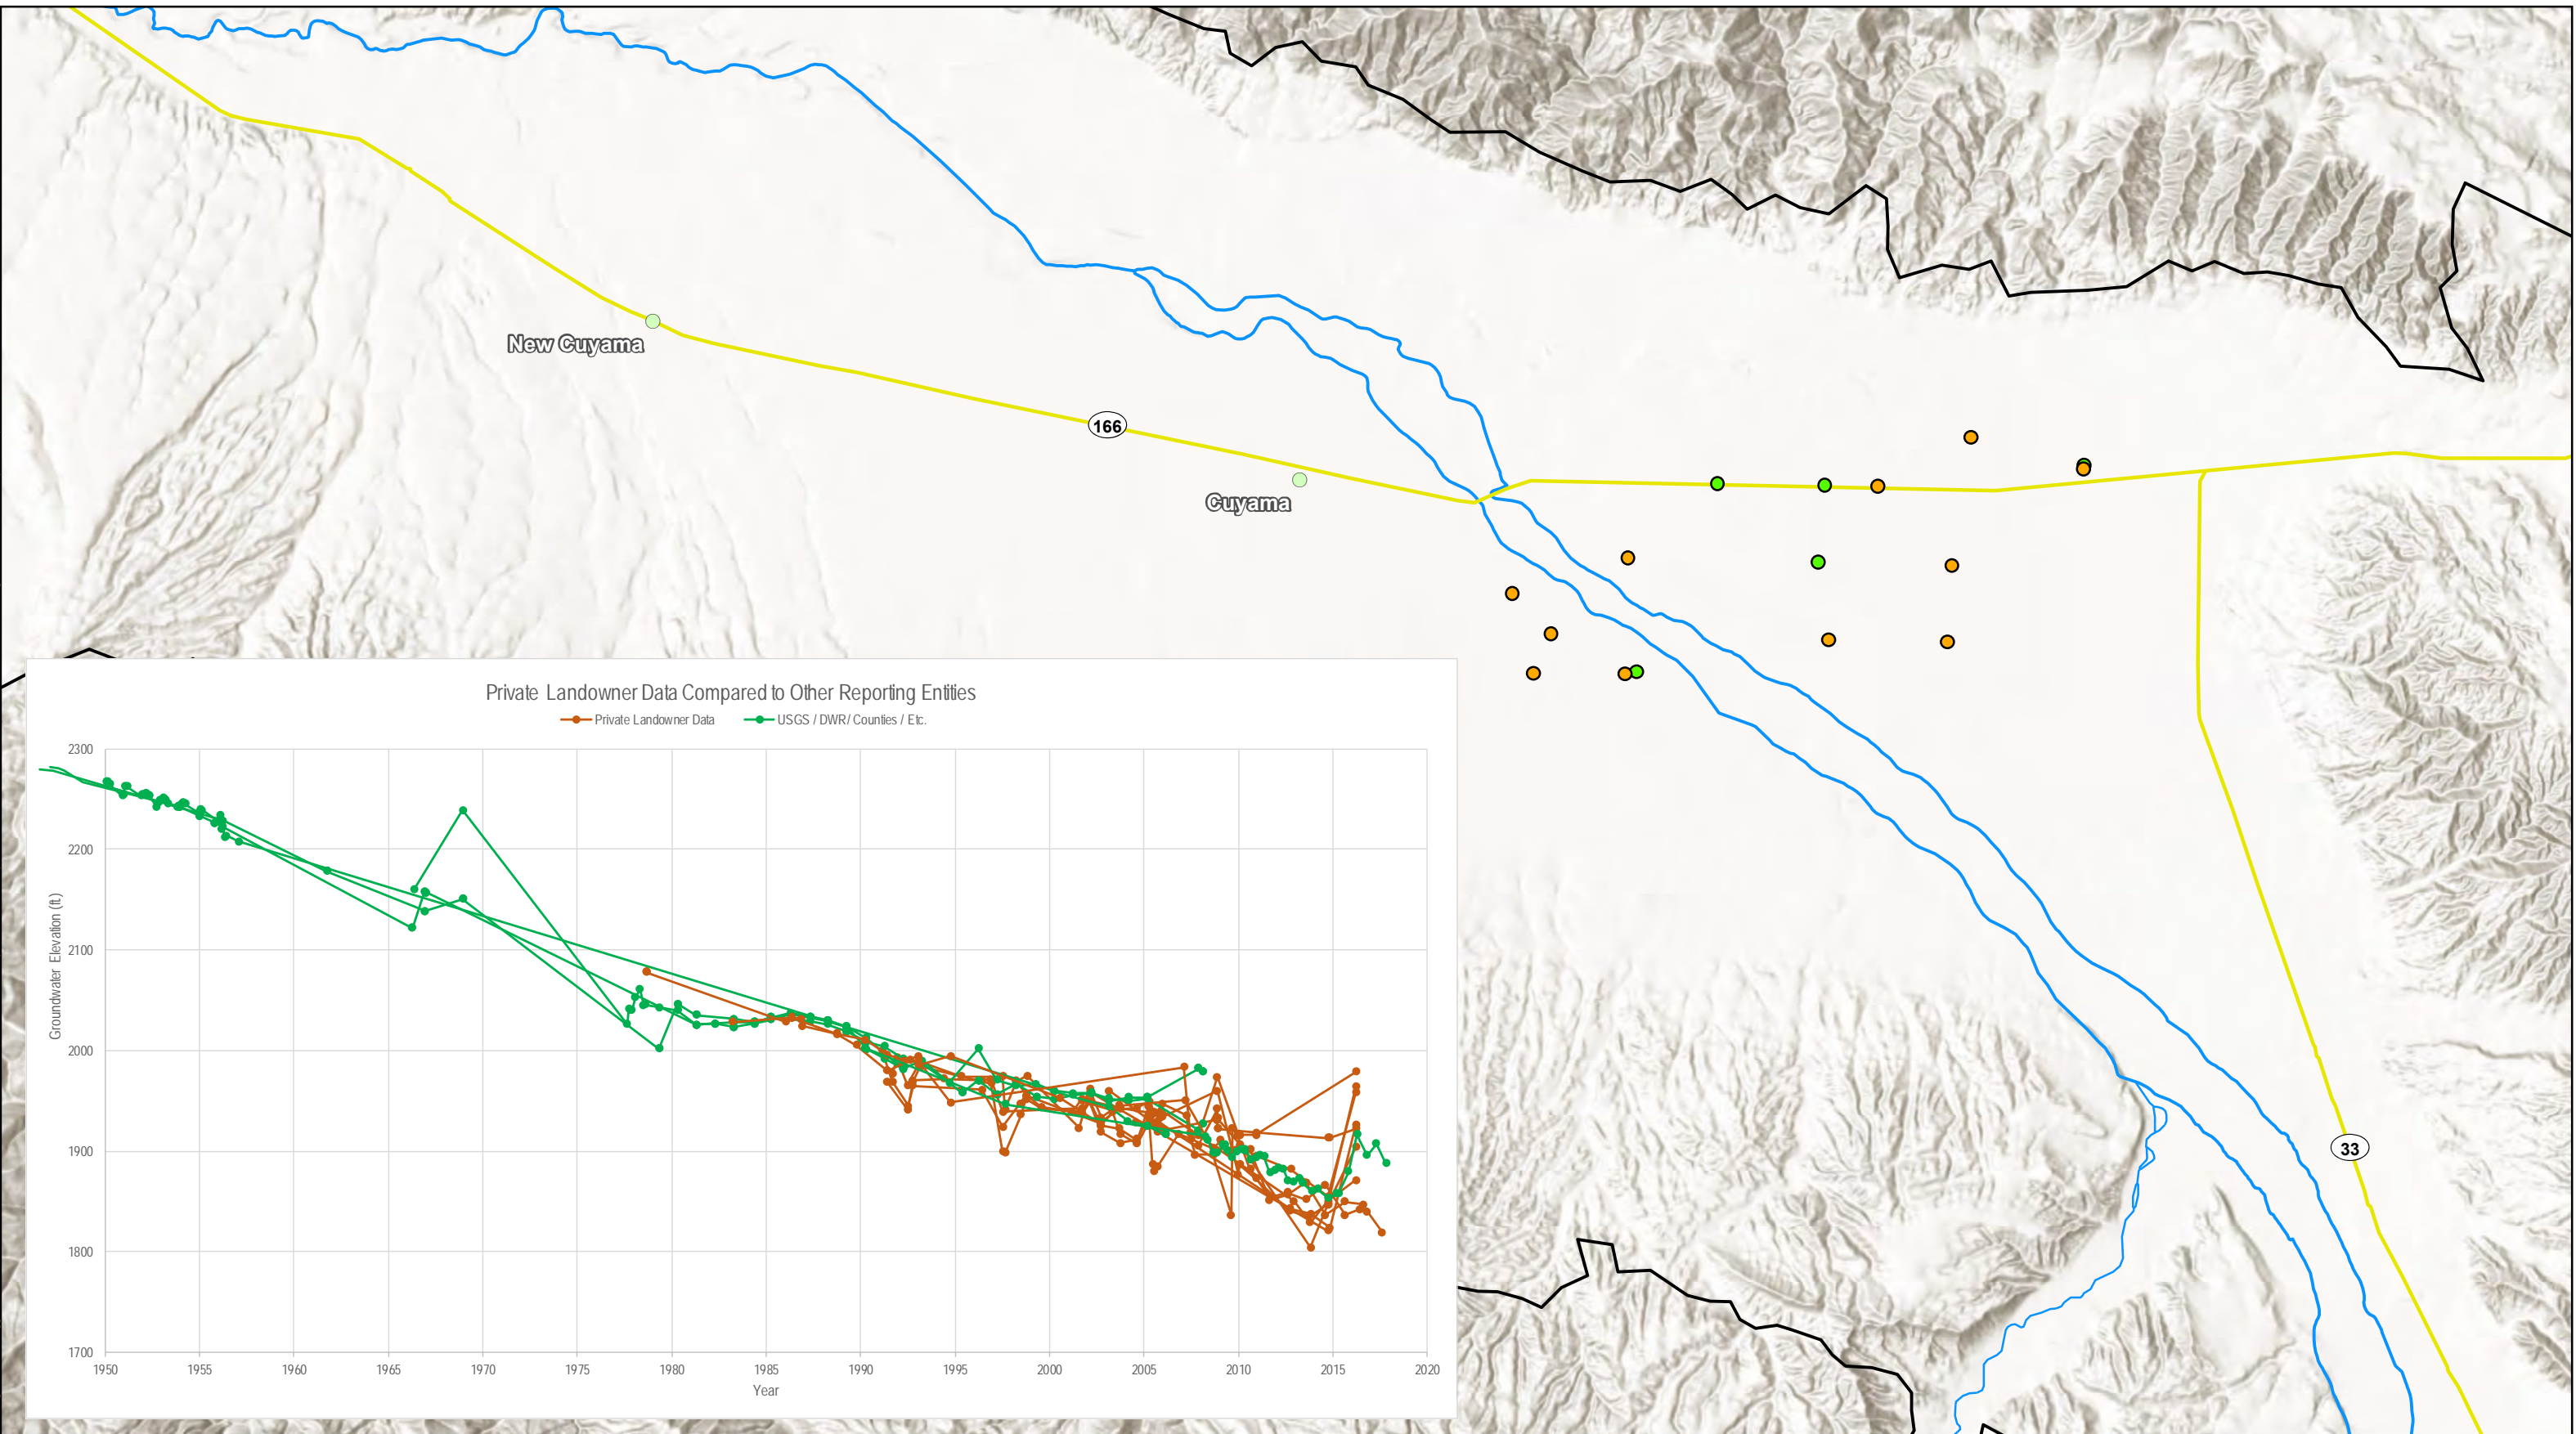
Figure 2.2-7: Central Cuyama GW Basin Wells and Hydrographs by Data Source

Figure 2.2-7 shows a comparison of data collected from private landowners and data collected from DWR and the USGS in the central portion of the Basin. The figure shows the location of compared wells, and the measurements on those wells by source. The measurements of groundwater elevation among the measured wells indicate that the monitoring by the private landowners and agencies match in tracking historical trends and are accurate measurements.

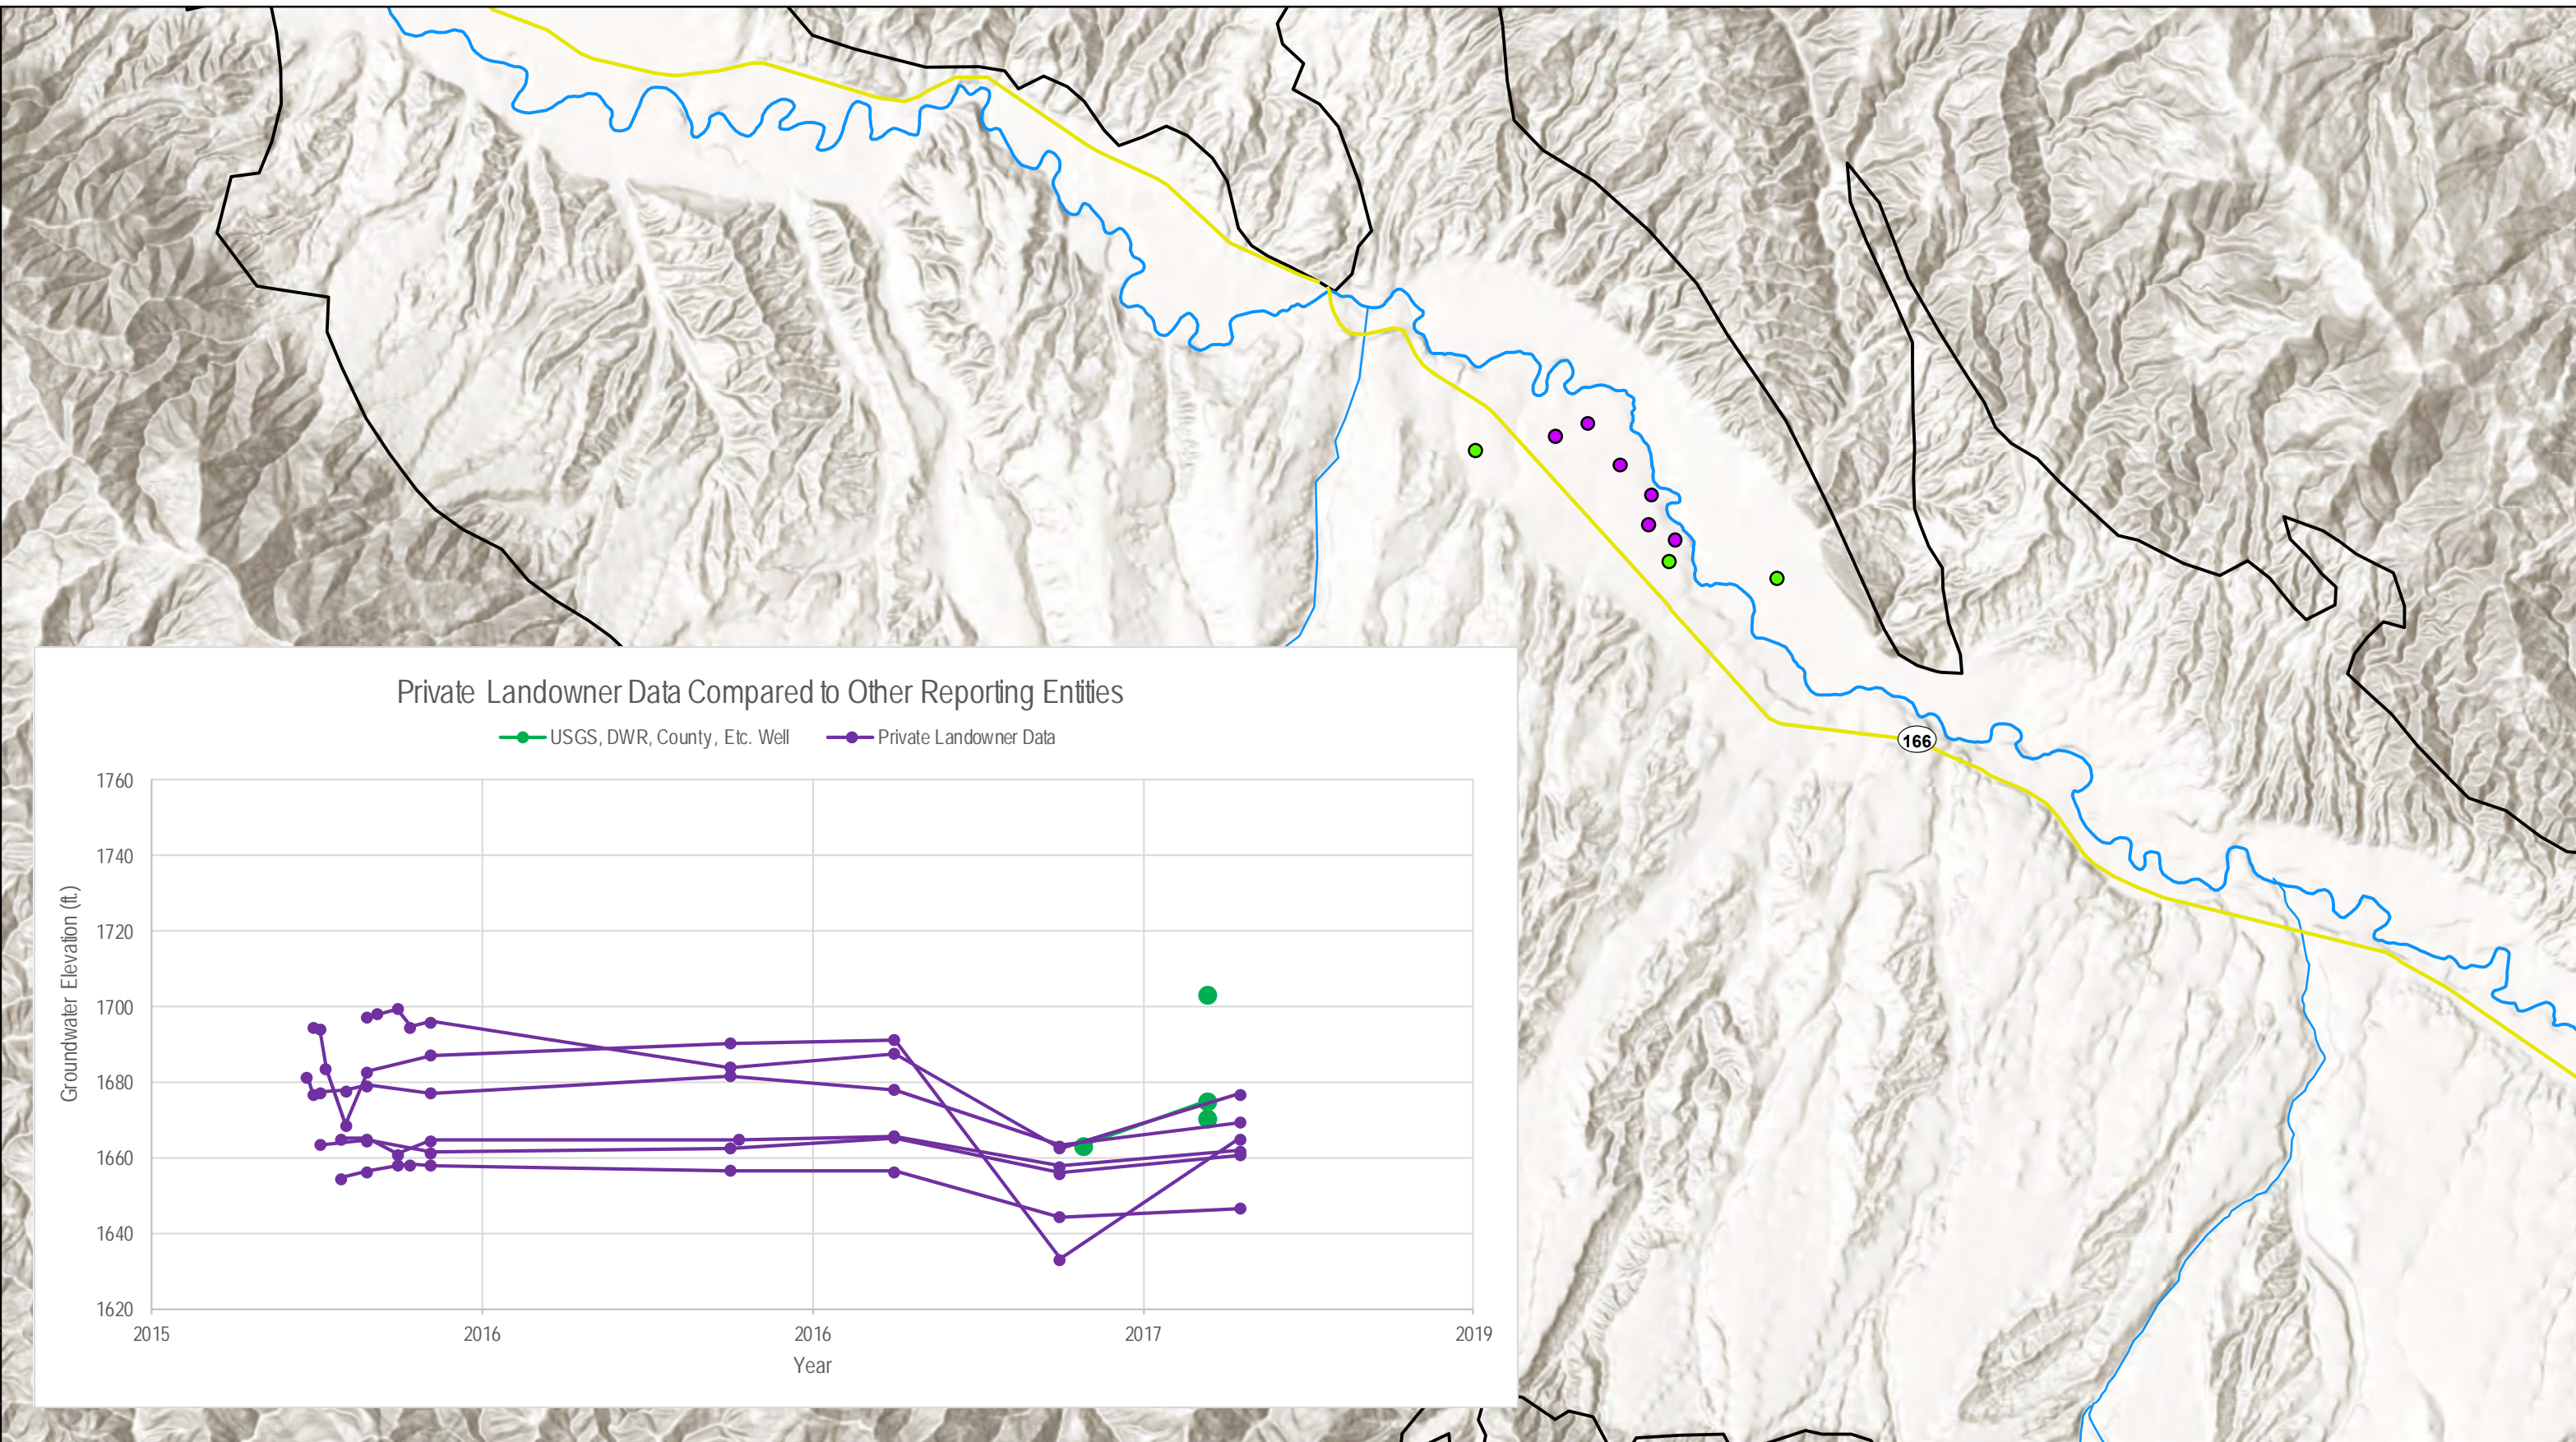
Figure 2.2-8: Western Cuyama GW Basin Wells and Hydrographs by Data Source
 Cuyama Basin Groundwater Sustainability Agency
 Cuyama Valley Groundwater Basin Groundwater Sustainability Plan
 August 2018

Figure 2.2-8 shows a comparison of data collected from other private landowners, and data collected from Santa Barbara County. The figure shows the location of compared wells, and the measurements on those wells by source. A long-term comparison is not possible due to the shorter measurement period of the Santa Barbara County wells, but the measurements of groundwater elevation among the measured wells indicate that the monitoring by private landowners in the western portion of the Basin and the county are similar in elevation, with the county's data showing slightly higher elevations.

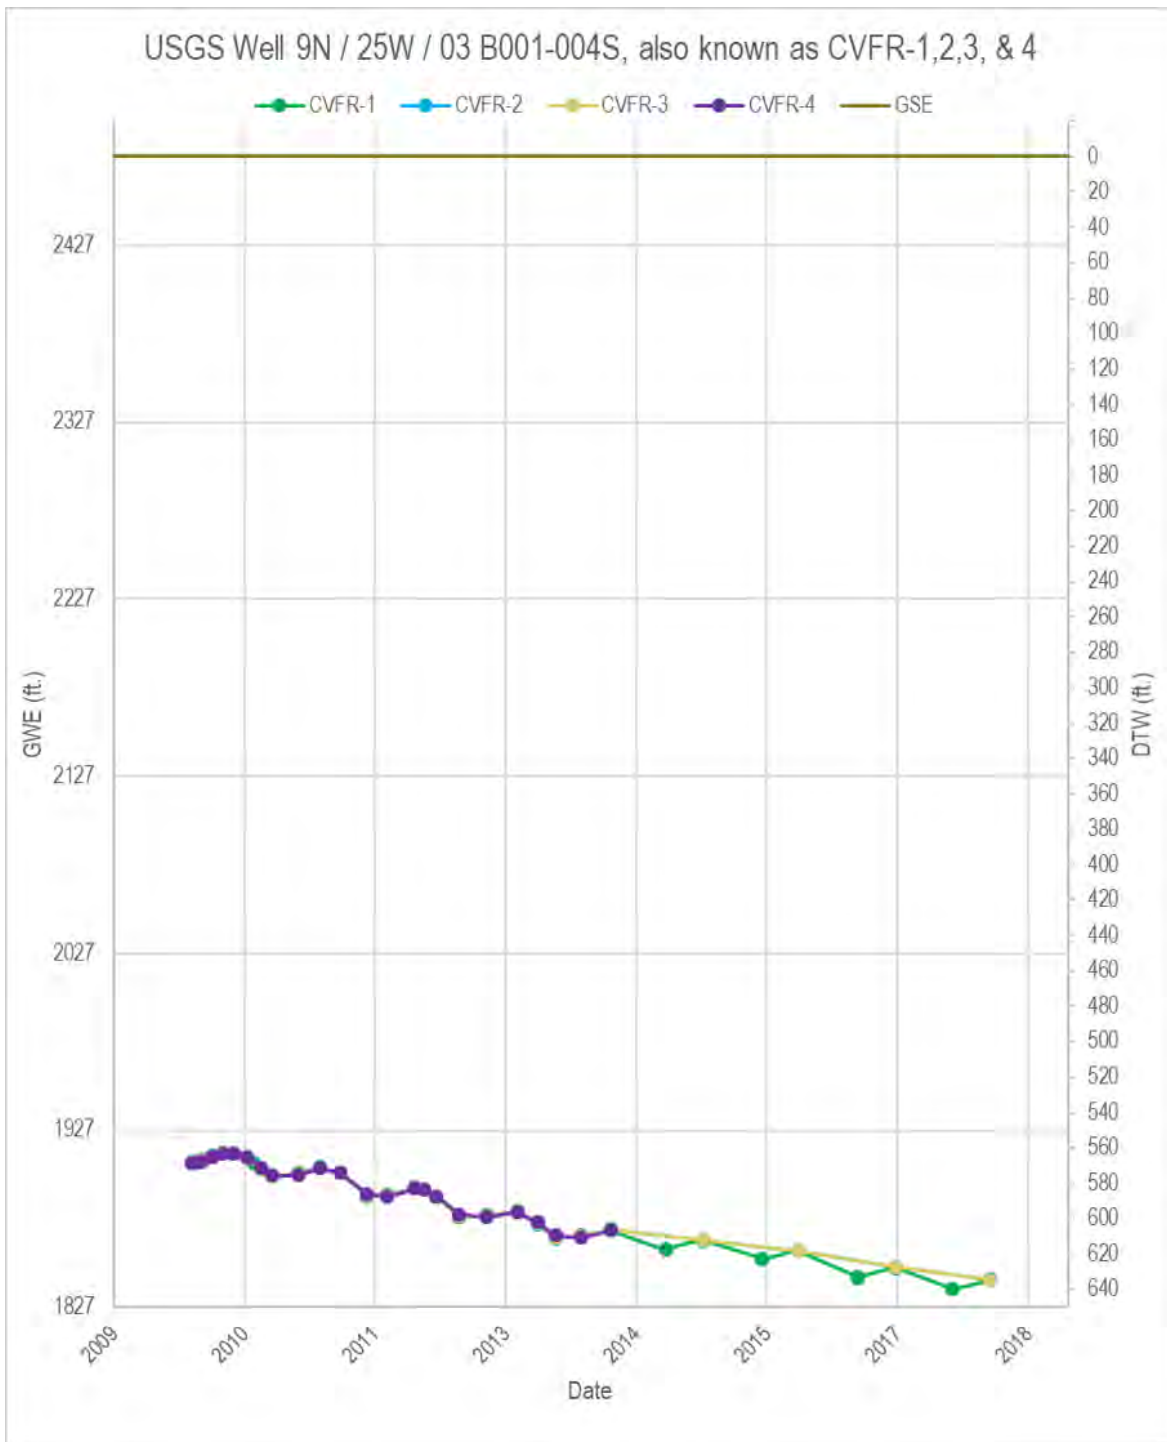
Figure 2.2-16: Hydrographs of CVFR1-4

The hydrograph of the four completions shows that at the deeper completions are slightly lower than the shallower completions in the spring at each completion, and deeper completions are generally lower in the summer and fall. This likely indicates that during the irrigation season, the deeper portions of the aquifer are where pumping occurs, which removes water from the deeper portion of the aquifer, creating a vertical gradient during the summer and fall. By the spring, enough water has moved down to replace removed water, and the vertical gradient is significantly smaller at this location in the spring measurements.

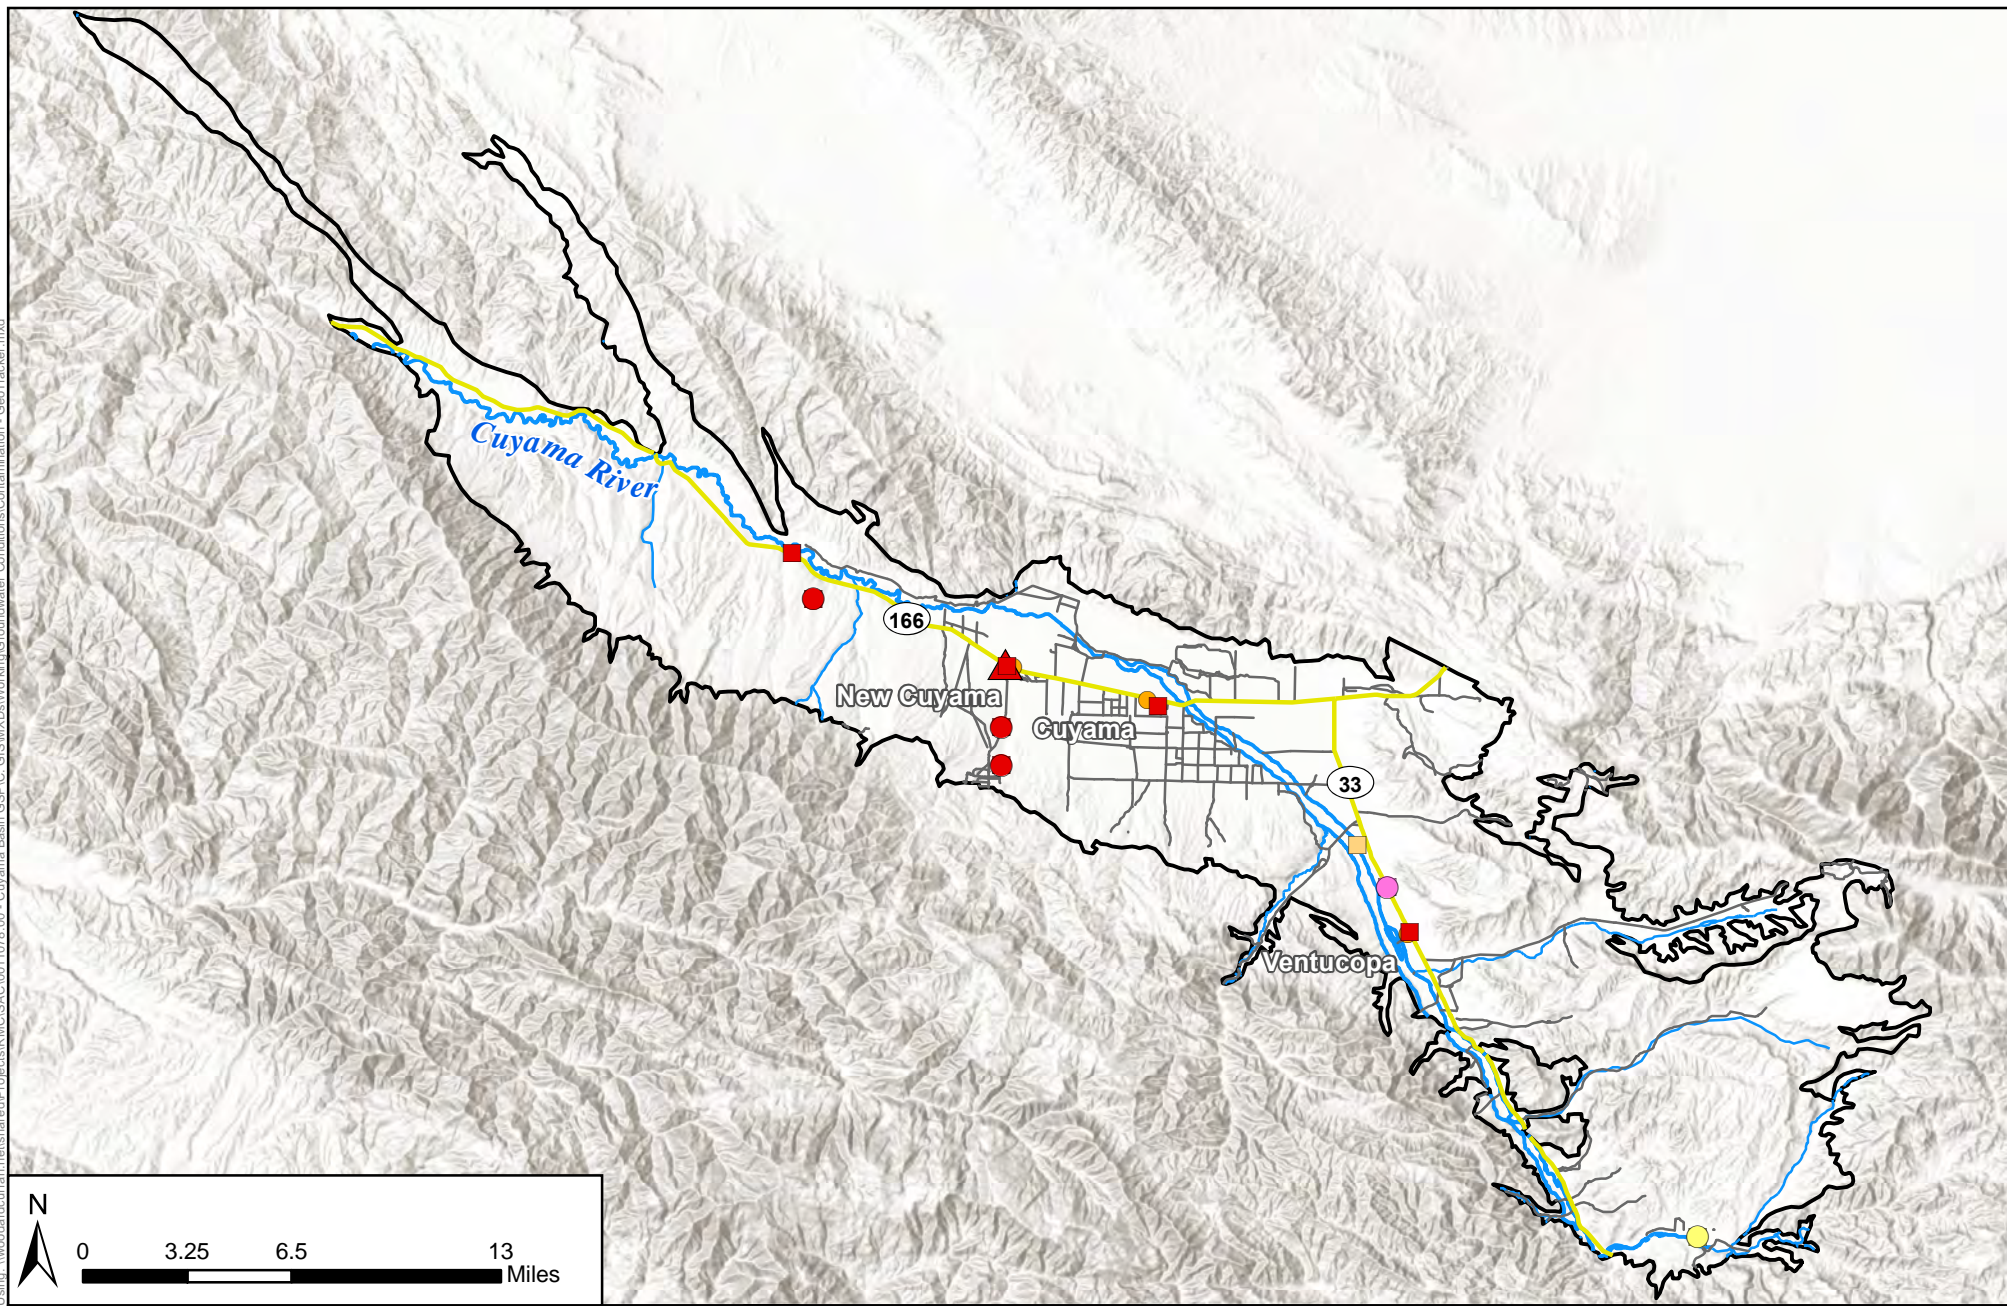
Figure 2.2-29 - Sites with Water Quality Concerns
Cuyama Basin Groundwater Sustainability Agency
Cuyama Valley Groundwater Basin Groundwater Sustainability Plan
August 2018

Figure 2.2-29: Known Contamination Sites shows the results of a query with the Regional Water Quality Control Board (RWQCB)'s Geotracker website. Geotracker documents contaminant concerns that the RWQCB is or has been working with site owners to clean up. Figure 2.2-29 shows that most of these sites are for fuels.

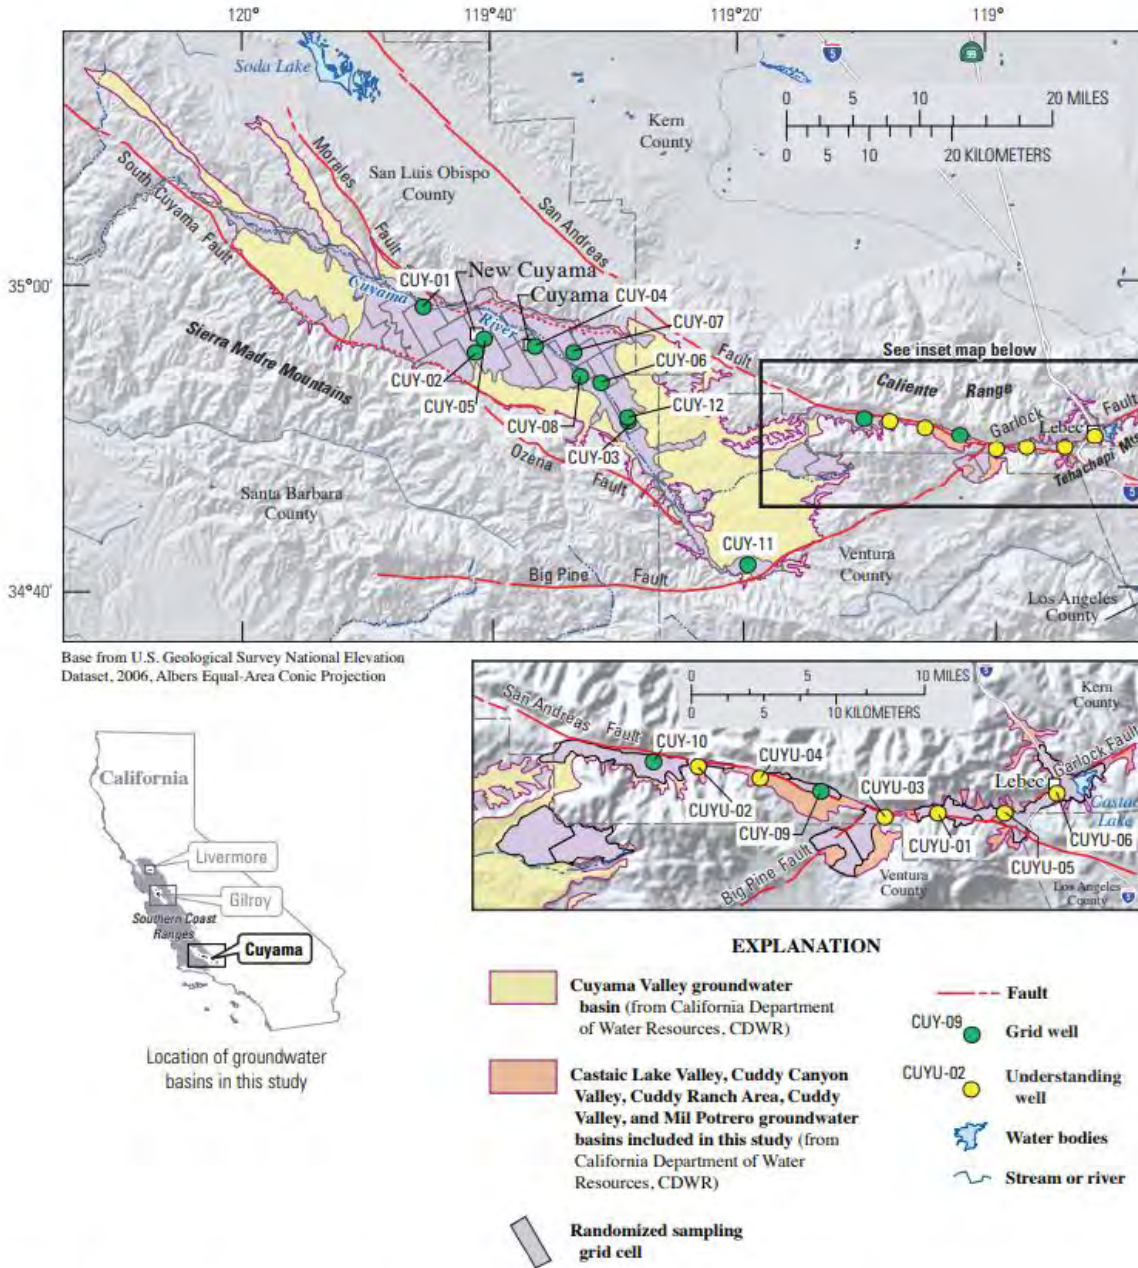
Figure 5. The South Coast Interior Basins Groundwater Ambient Monitoring and Assessment (GAMA) study unit showing the distribution of the Cuyama study-area grid cells, the location of sampled grid wells and understanding wells, the Cuyama Valley, Castaic Lake Valley, Cuddy Canyon Valley, Cuddy Ranch Area, Cuddy Valley, and Mil Potrero groundwater-basin boundaries (as defined by the California Department of Water Resources, CDWR), major cities, major roads, topographic features, and hydrologic features. Alphanumeric identification numbers for grid wells

- Manganese exceeded its SMCL in two wells.
- Arsenic exceeded the MCL in one well.
- Nitrate exceeded the MCL in two wells
- Sulfate exceeded its MCL in eight wells
- TDS exceeded its MCL in 7wells
- VOCs detected in one well.
