Cuyama Valley Groundwater Basin
Groundwater Sustainability Plan
Groundwater Conditions
Revised Draft

November 2018

Chapter 2 Chapter 2.2 Groundwater Conditions

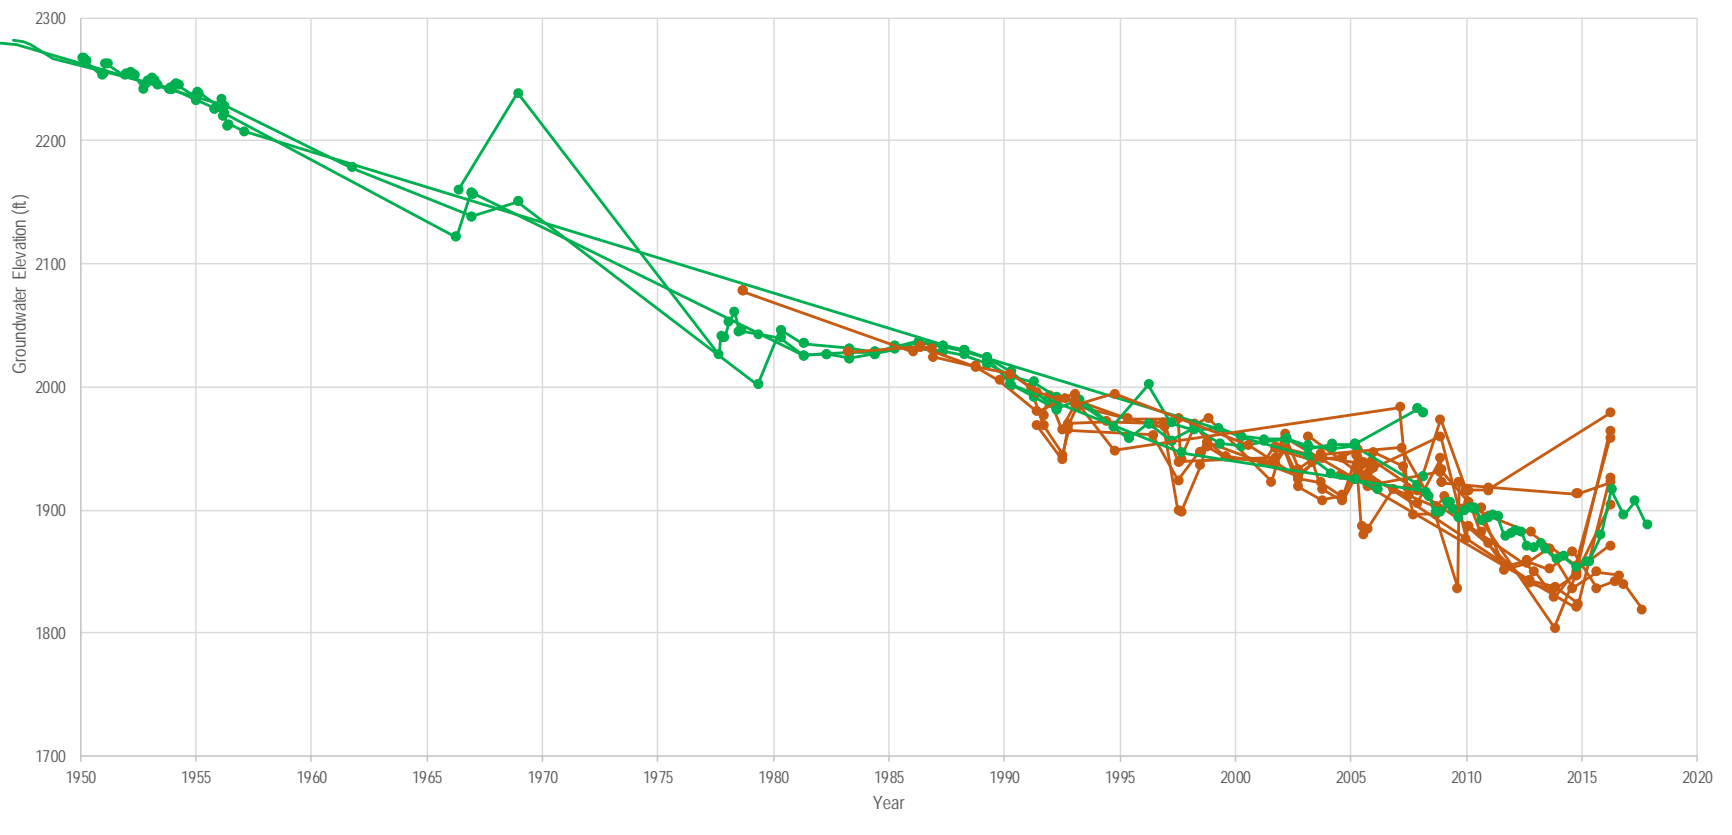
Figure 2.2-7: Central Cuyama GW Basin Wells and Hydrographs by Data Source
 Cuyama Basin Groundwater Sustainability Agency
 Cuyama Valley Groundwater Basin Groundwater Sustainability Plan
 August 2018

Figure 2.2-7 shows a comparison of data provided by private landowners and data compiled from the DWR and the USGS databases in the central portion of the Basin. This figure was developed to provide information on the consistency between data from these differing sources. The figure shows the location of compared wells, and the measurements on those wells by source. The measurements of groundwater elevation among the measured wells indicate that the monitoring by the private landowners and agencies approximately match in tracking historical trends from the public databases.

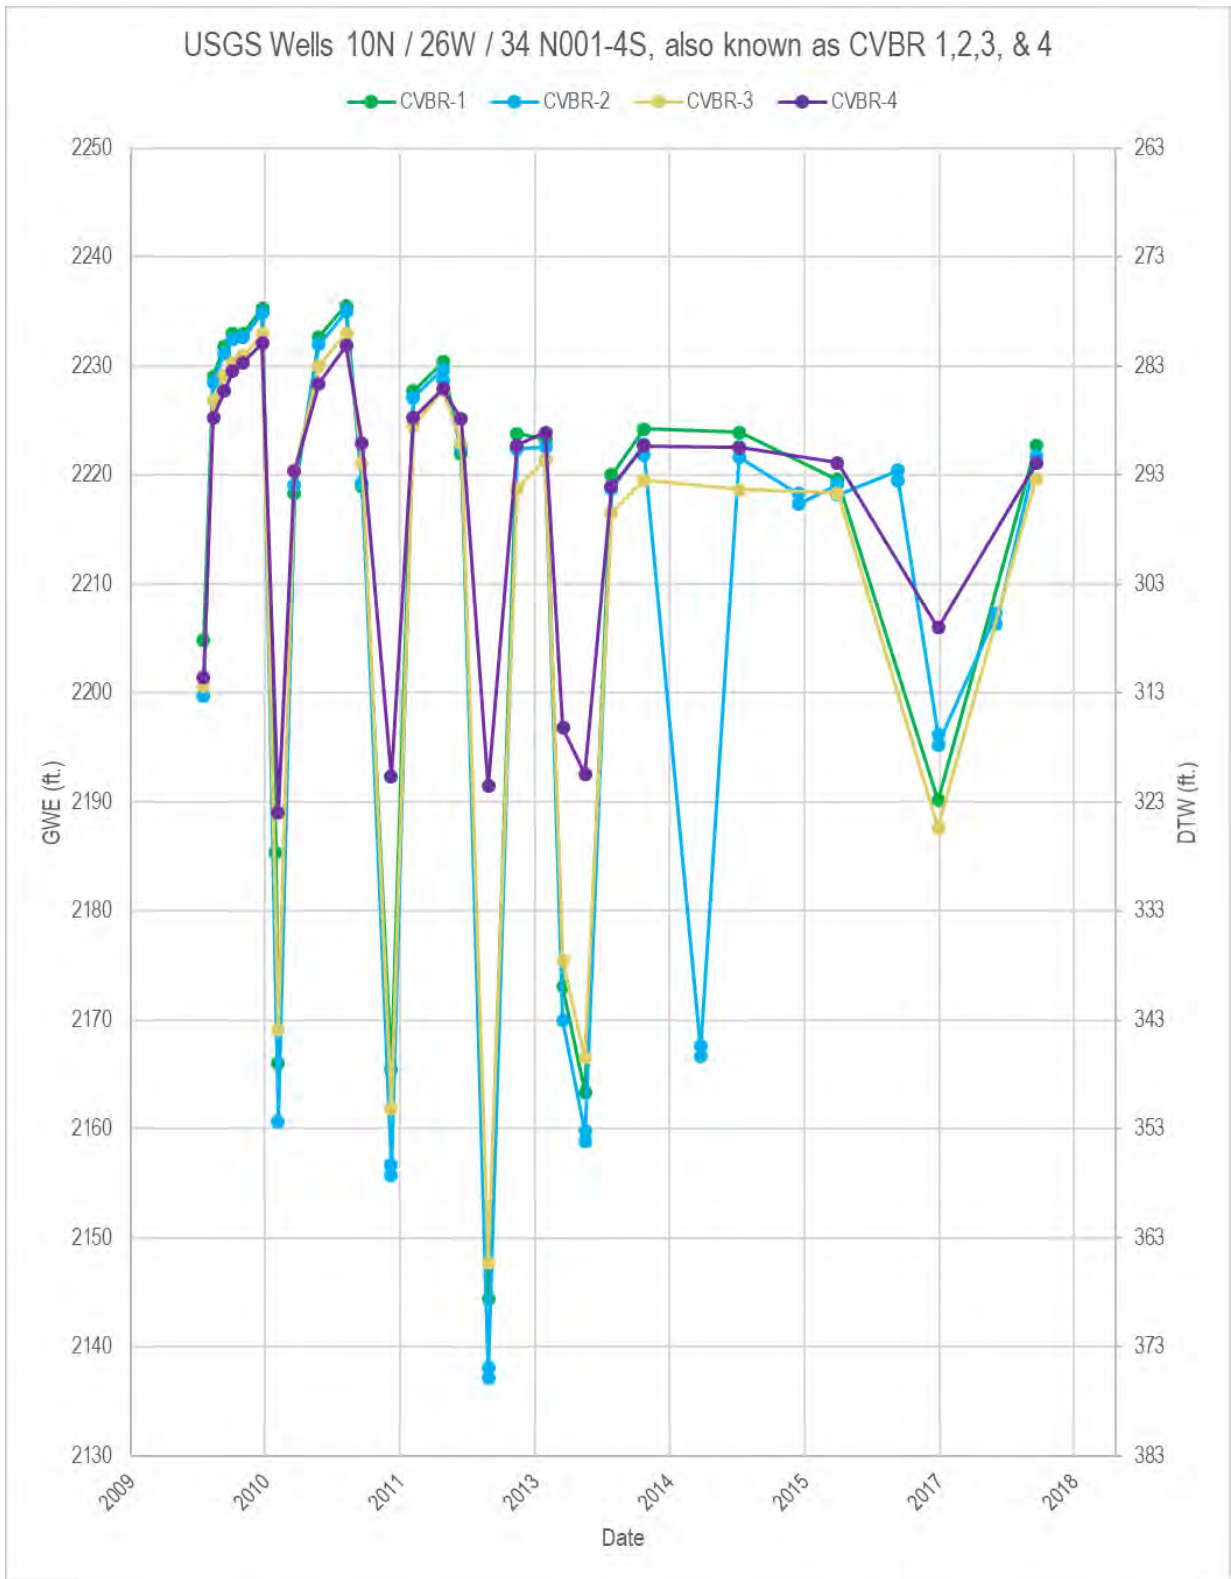
Figure 2.2-17: Hydrographs of CVBR1-4

The hydrograph of the four completions shows that at the deeper completions are slightly lower than the shallower completions in the spring at each completion, and deeper completions are generally lower in the summer and fall. This indicates that during the irrigation season, the deeper portions of the aquifer are likely to be where pumping occurs. This pumping removes water from the deeper portion of the aquifer, creating a vertical gradient during the summer and fall. By the winter and spring, enough water has moved down to replace removed water, and the vertical gradient is very small at this location in the spring measurements.
