CUYAMA BASIN GROUNDWATER SUSTAINABILITY AGENCY STANDING ADVISORY COMMITTEE

AGENDA

August 30, 2018

Cuyama Valley Groundwater Basin Groundwater Sustainability Plan Groundwater Conditions Draft

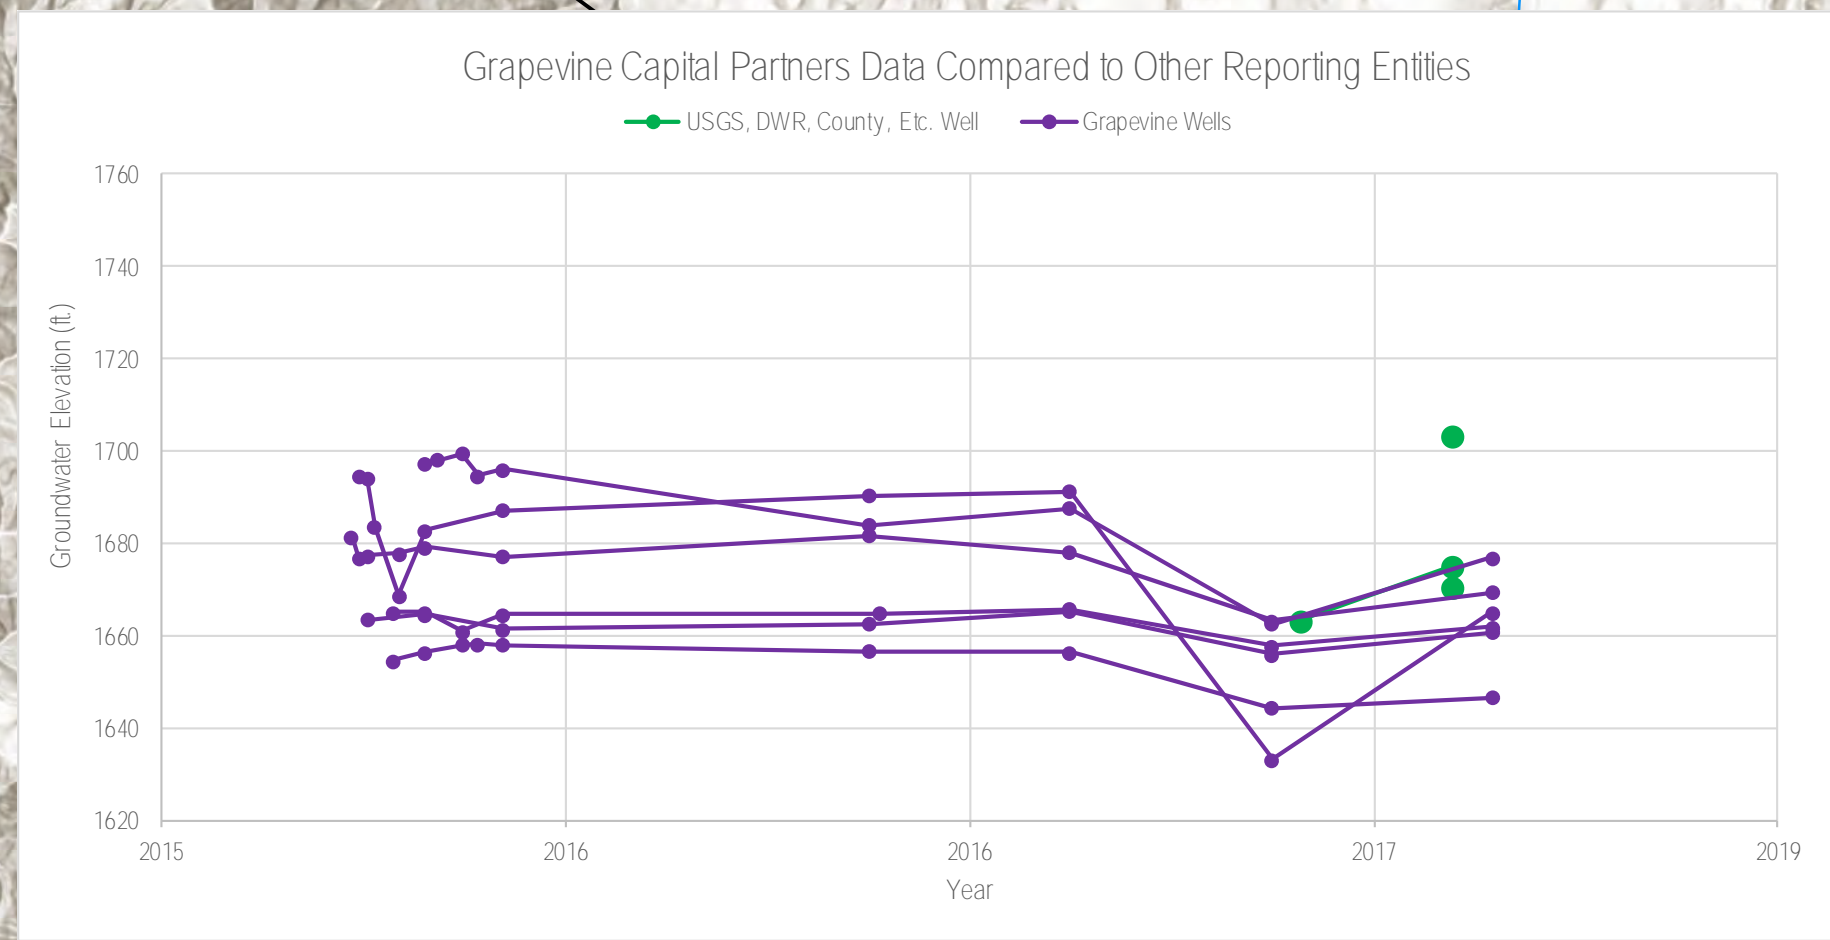
Figure 2.2-8: Cuyama GW Basin Wells by Groundwater Surface Elevation
 Cuyama Basin Groundwater Sustainability Agency
 Cuyama Valley Groundwater Basin Groundwater Sustainability Plan
 August 2018
