# JOINT MEETING OF CUYAMA BASIN GROUNDWATER SUSTAINABILITY AGENCY BOARD OF DIRECTORS AND STANDING ADVISORY COMMITTEE

## AGENDA

December 3, 2018

## Chapter 2 Chapter 2.2 Groundwater Conditions

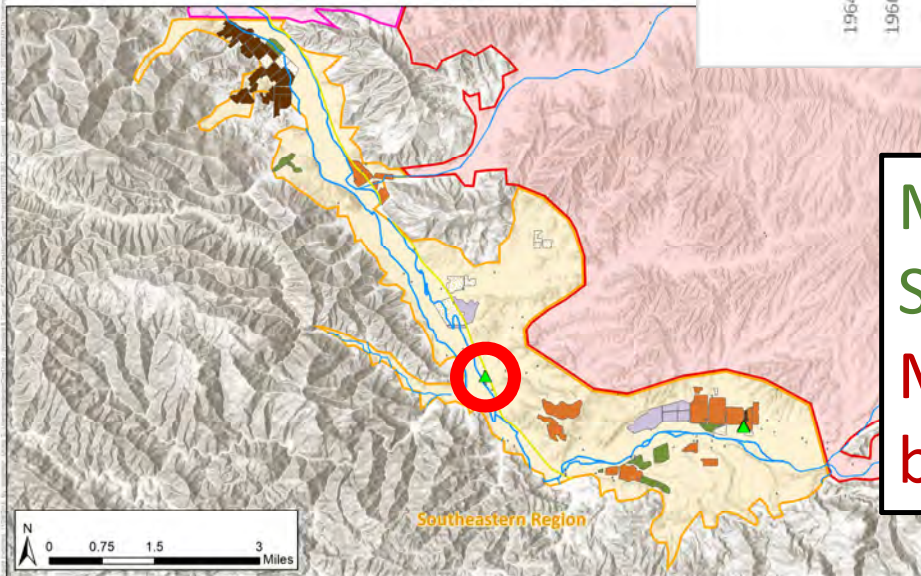
# Southeastern Region

## Propose 20% of Range

Measurable Objective – 5-years of Storage

Minimum Threshold – 20% of Range below 1/1/2015 Measurement
