2. BASIN SETTINGS: OVERVIEW

2.1 Basin Settings: HCM

2.2 Basin Settings: Groundwater Conditions

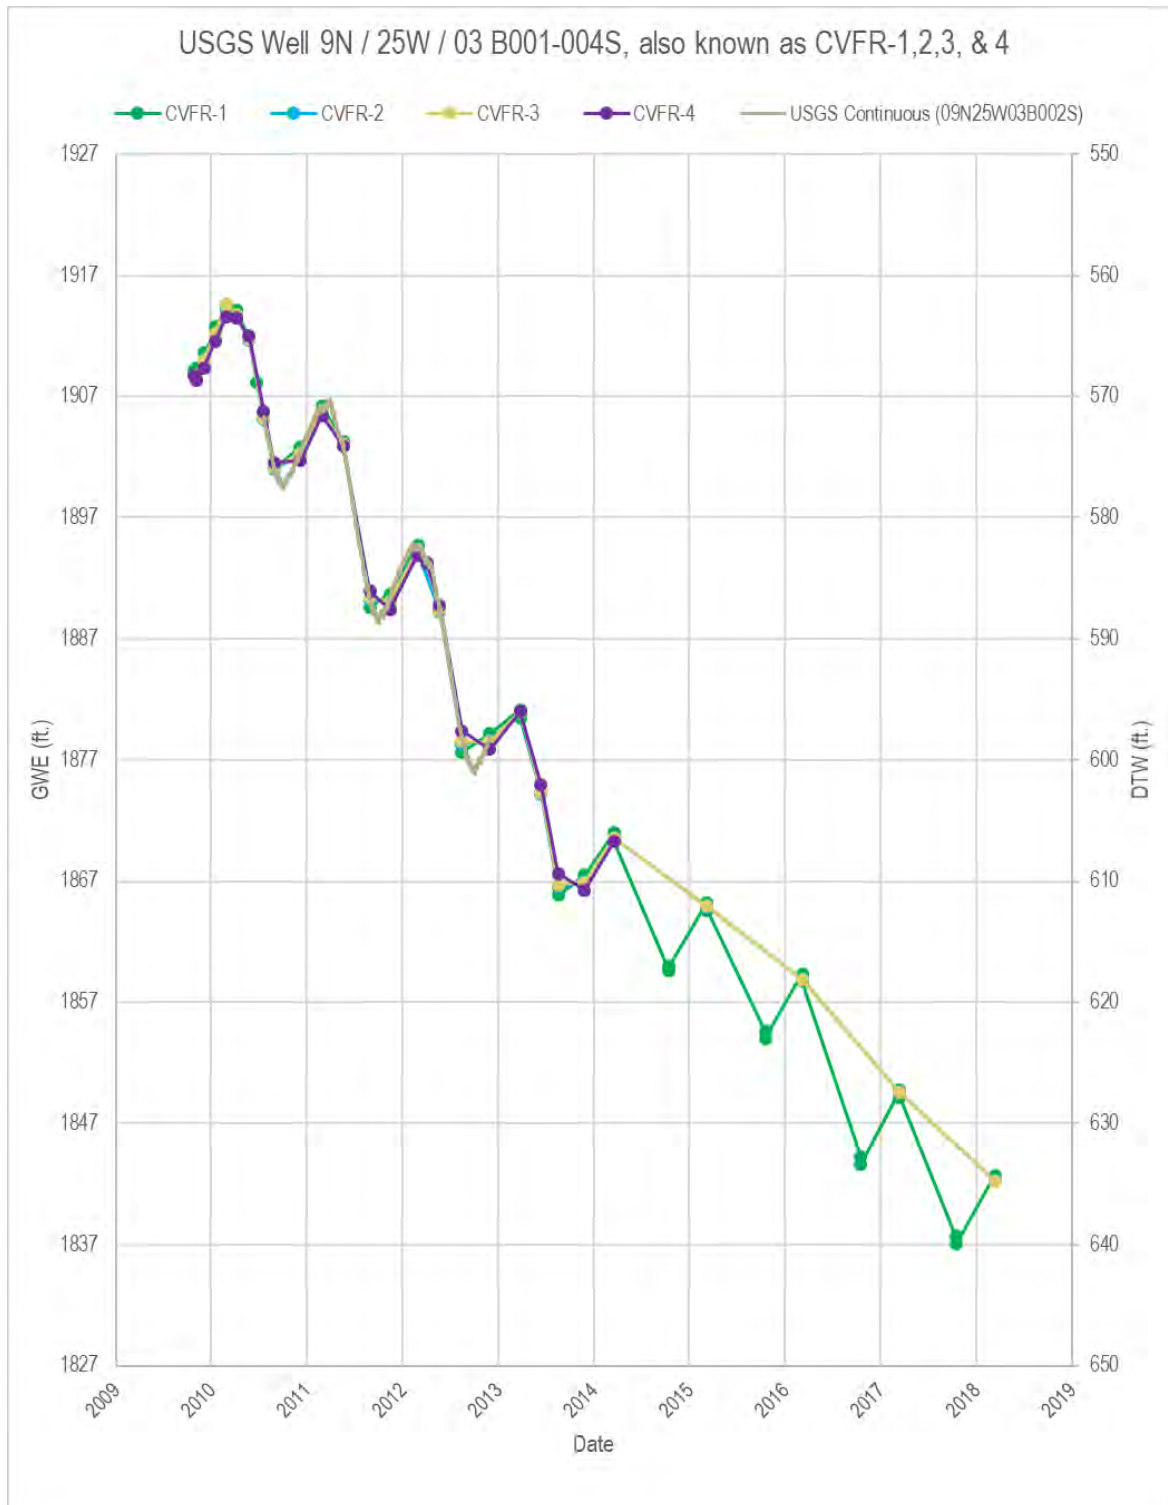
Figure 2-36: Hydrographs of CVFR1-4

The hydrograph of the four completions shows that at the deeper completions, groundwater elevations are slightly lower than the shallower completions in the winter and spring, and deeper completions are generally lower than the shallower completion in the summer and fall. This indicates that during the irrigation season, the deeper portions of the aquifer are likely to be where pumping occurs. This pumping removes water from the deeper portion of the aquifer, creating a vertical gradient during the summer and fall. By the spring, enough water has moved down or horizontally to replace removed water, and the vertical gradient is significantly smaller at this location in the spring measurements.
