2. BASIN SETTINGS: OVERVIEW

2.1 Basin Settings: HCM

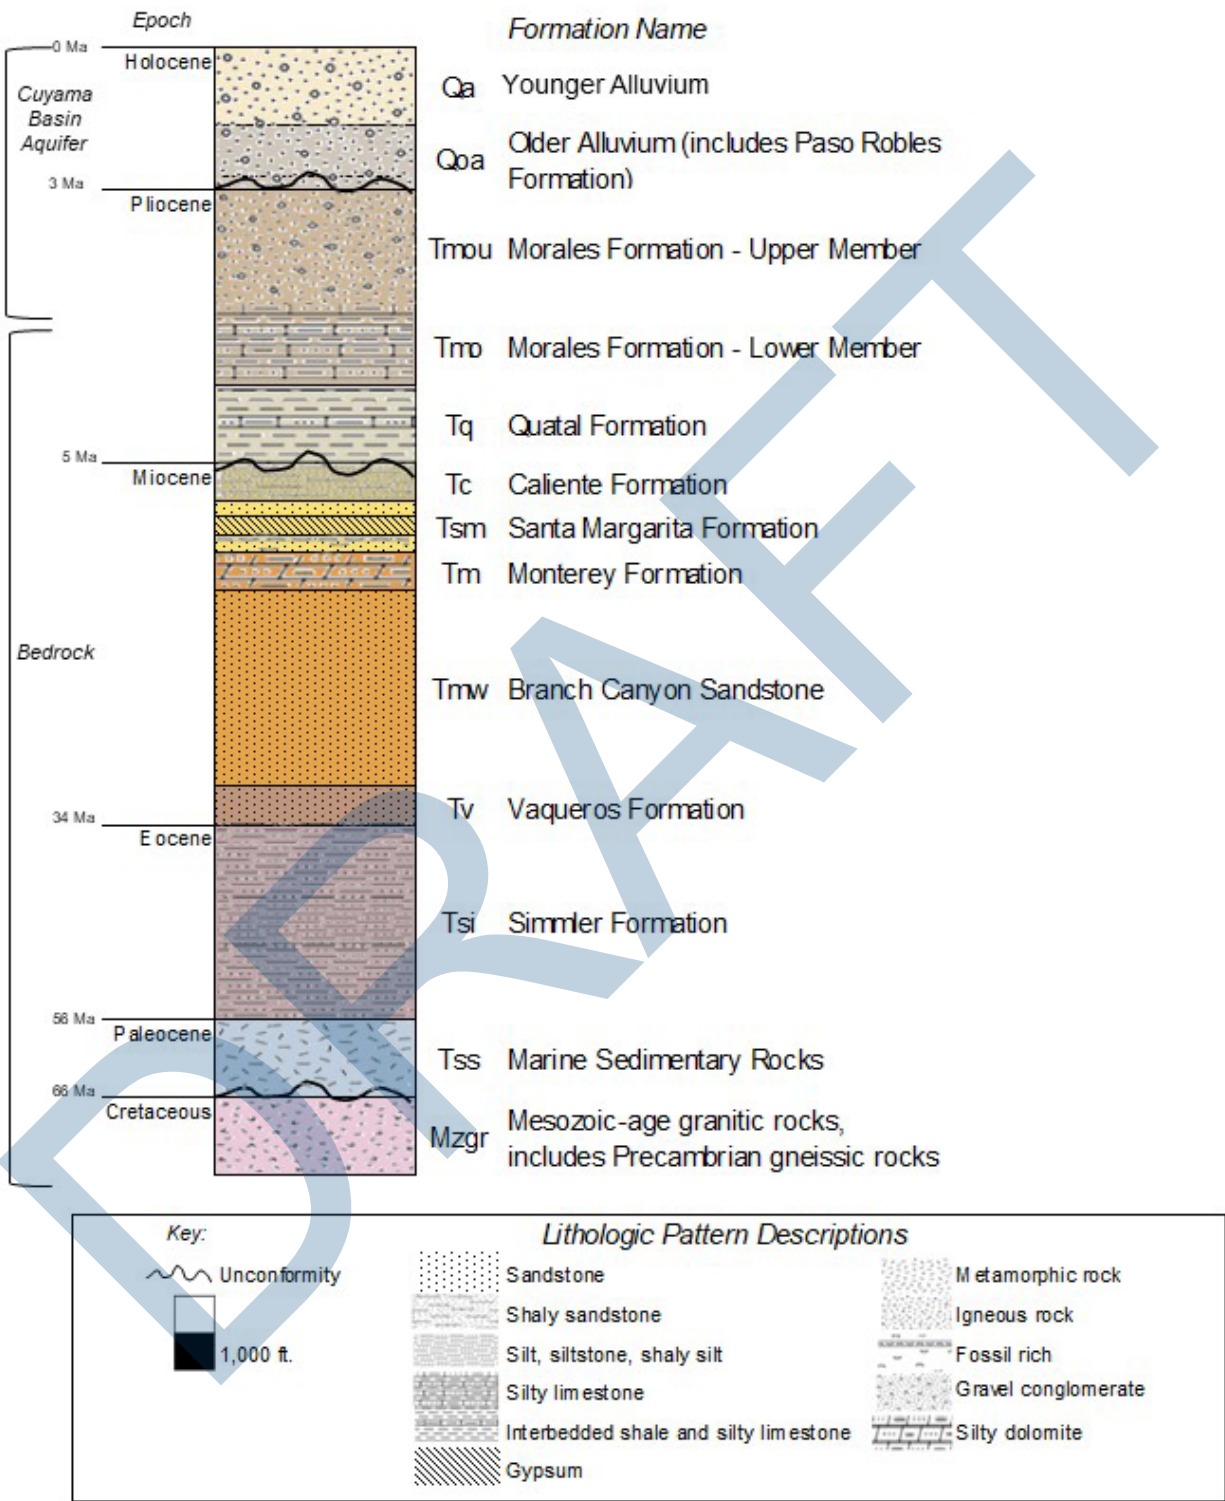
Stratigraphic Units of the Cuyama Basin Aquifer

The Basin is composed of a sequence of unconsolidated to partly consolidated nonmarine deposits of Pliocene to Pleistocene age unconformably overly consolidated marine and nonmarine sedimentary rocks of late Cretaceous to middle Cenozoic age on top of Mesozoic crystalline granitic and gneissic bedrock (Davis et al., 1988). The unconsolidated to partly consolidated nonmarine deposits are the primary water-bearing units in the Basin and are described in further detail in Section 2.1.7. Individual geologic units found in the Basin are described in detail below, in order of youngest to oldest in deposition. Geologic units mapped at the surface are shown in Figure 2-2. A generalized stratigraphic column of the Cuyama Valley is shown in Figure 2-3.

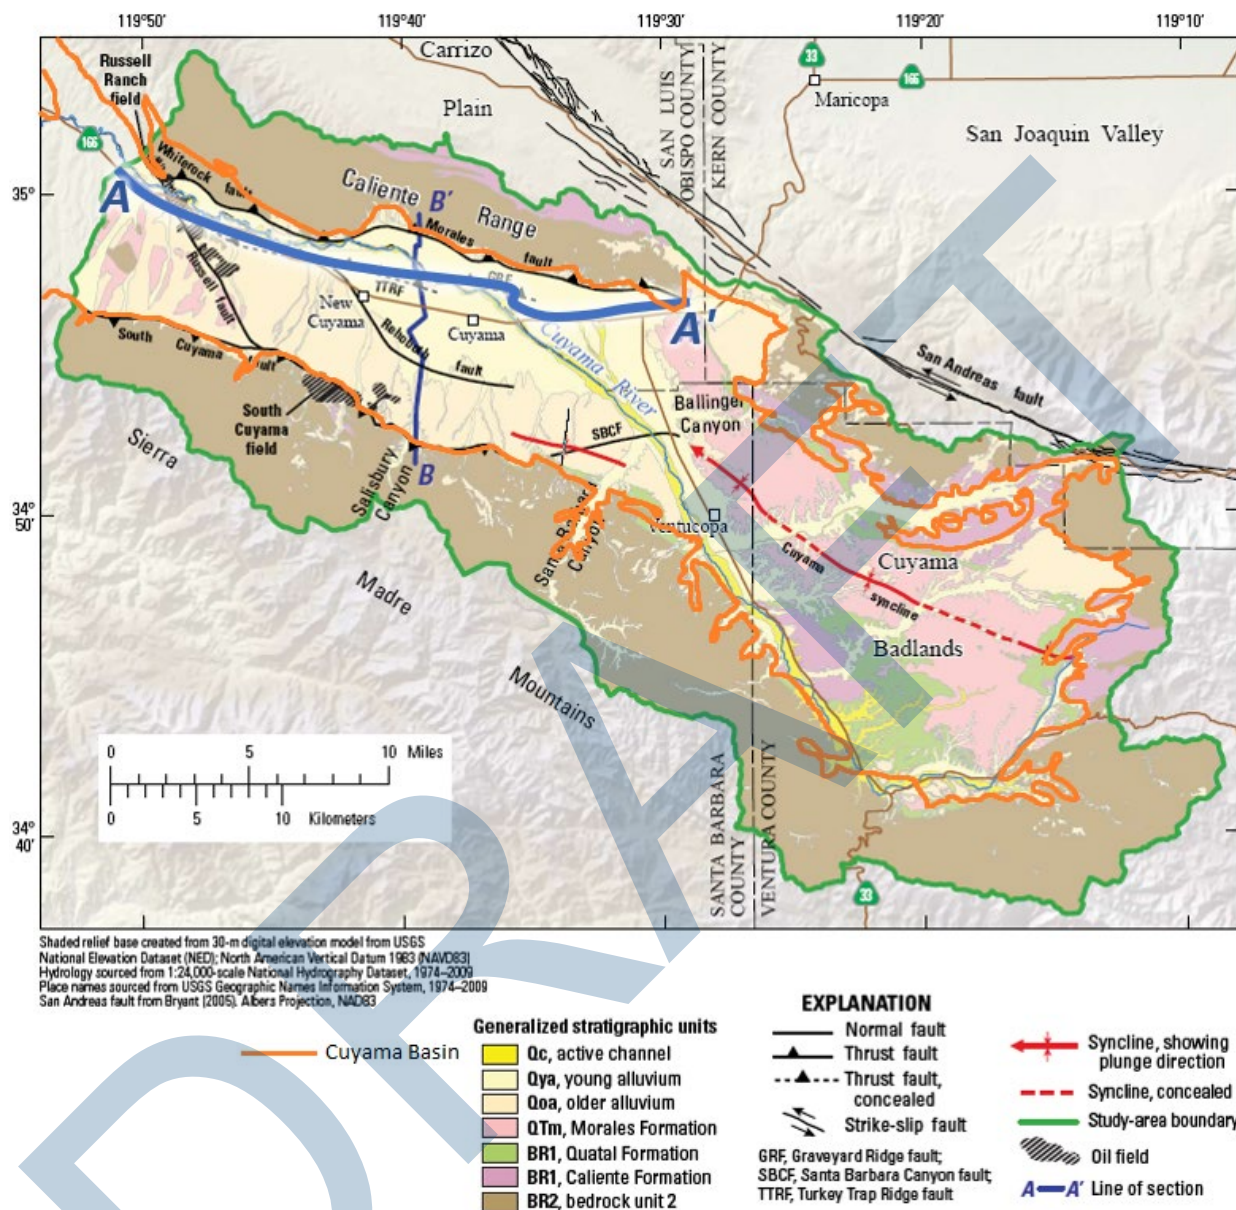
Figure 2-5 shows the locations of cross sections across the central portion of the Basin prepared by USGS in 2013. Figure 2-5 shows a west-east cross section that runs near the towns of New Cuyama and Cuyama labeled A-A', and a south-north cross section labeled B-B'. Figure 2-6 shows the A-A' cross section and Figure 2-7 shows the B-B' cross section. Cross-section A-A' shows the layering of Recent and Old alluvial aquifers and the Morales Formation aquifer. It also shows where the Russell Fault and Turkey Trap Ridge Fault cross the cross section, and shows groundwater elevation. Figure 2-7 shows cross section B-B', which shows layering of the aquifers and the locations where the Rehoboth and Graveyard Ridge fault cross the cross section.

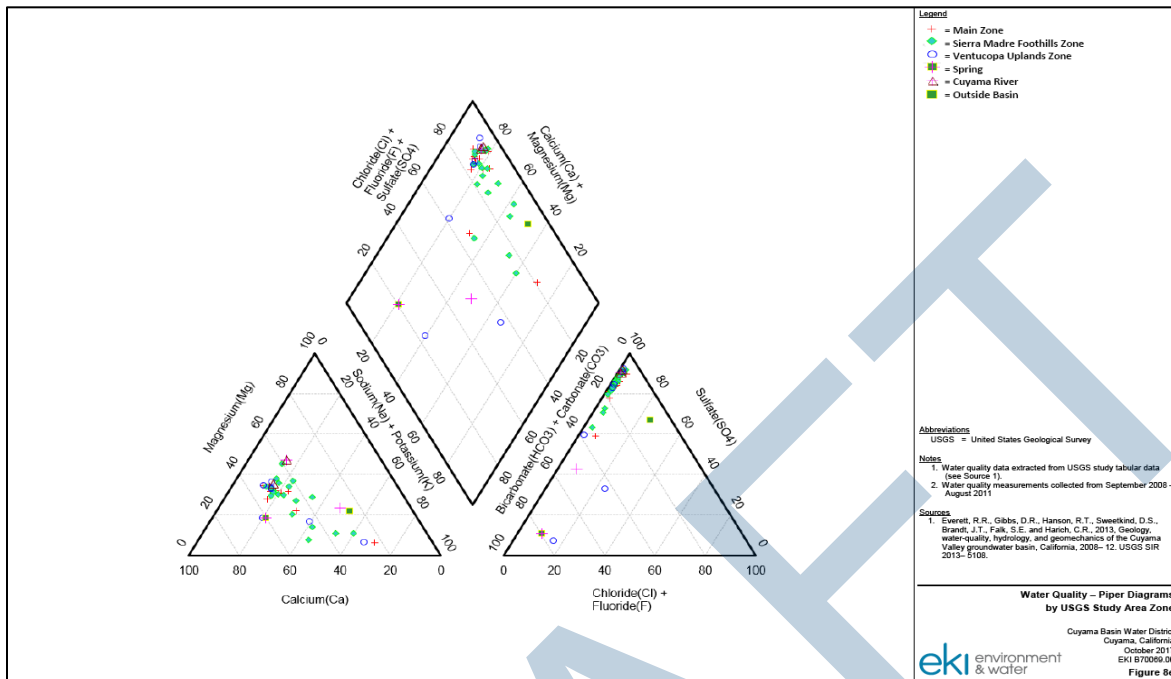
Figure 2-14: Piper Diagram of USGS 2013 Water Quality Sampling

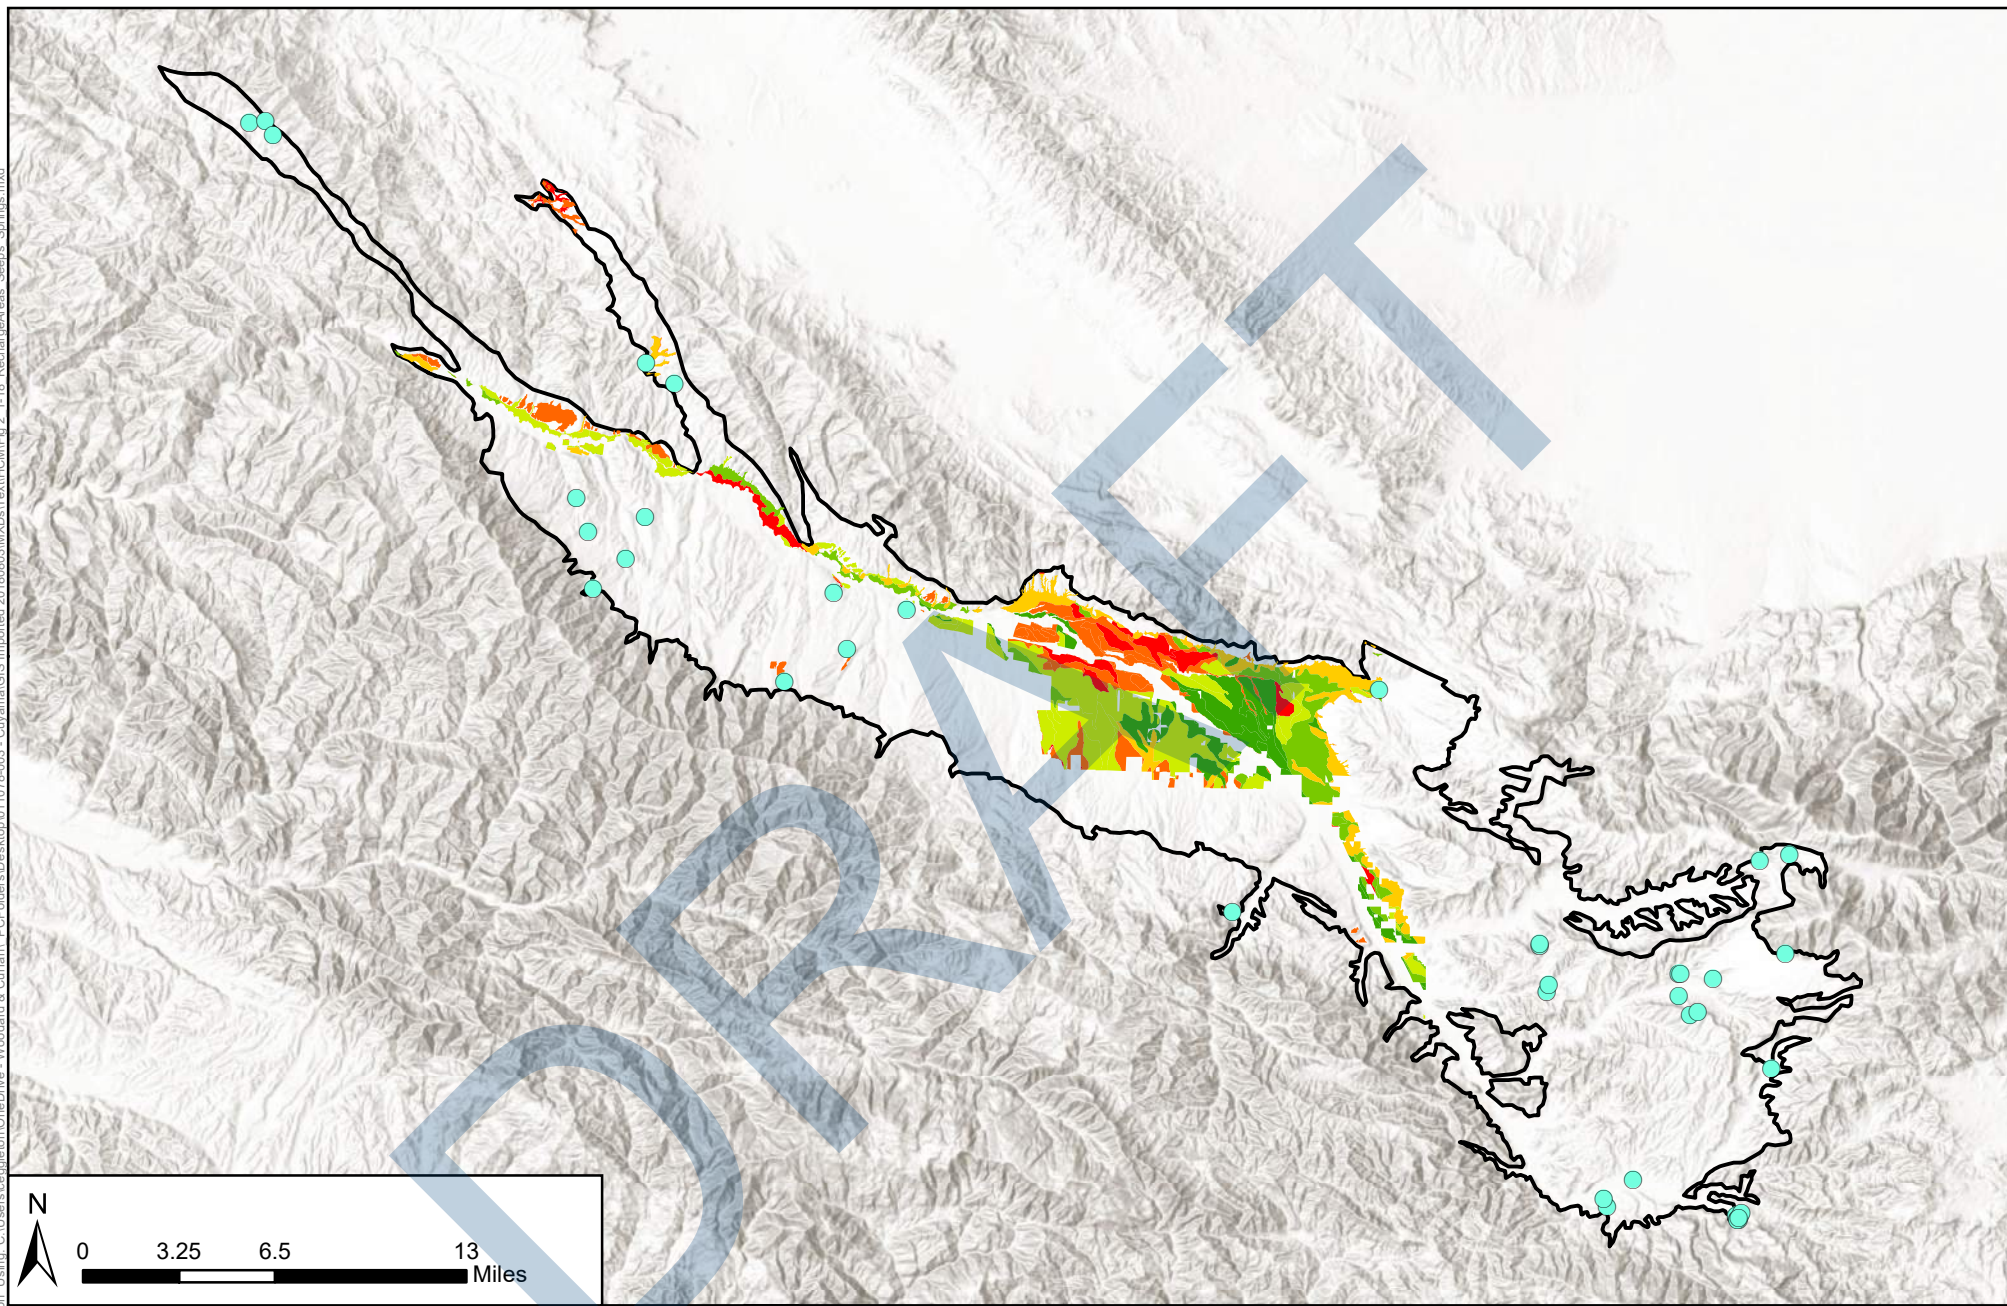
Figure 2-18: Recharge Areas, Seeps, and Springs

Areas of recharge and potential recharge lie primarily within the central and low-lying areas of the Cuyama Valley. Agricultural and open space lands are considered areas of potential recharge. Figure 2-18 shows areas with their potential for groundwater recharge, as identified by the Soil Agricultural Groundwater Banking Index (SAGBI). SAGBI provides an index for the groundwater recharge for agricultural lands by considering deep percolation, root zone residence time, topography, chemical limitations, and soil surface condition. SAGBI data categorizes 22,675 acres out of 37,568 acres (60 percent) of agricultural and grazing land within the Basin as moderately good, good, or excellent for groundwater recharge (University of California, Davis, 2018). SAGBI data shown in Figure 2-18 is derived from “modified” SAGBI data. “Modified” SAGBI data show higher potential for recharge than unmodified SAGBI data because the modified data assume that the soils have been or will be ripped to a depth of 6 feet, which can break up fine grained materials at the surface to improve percolation.

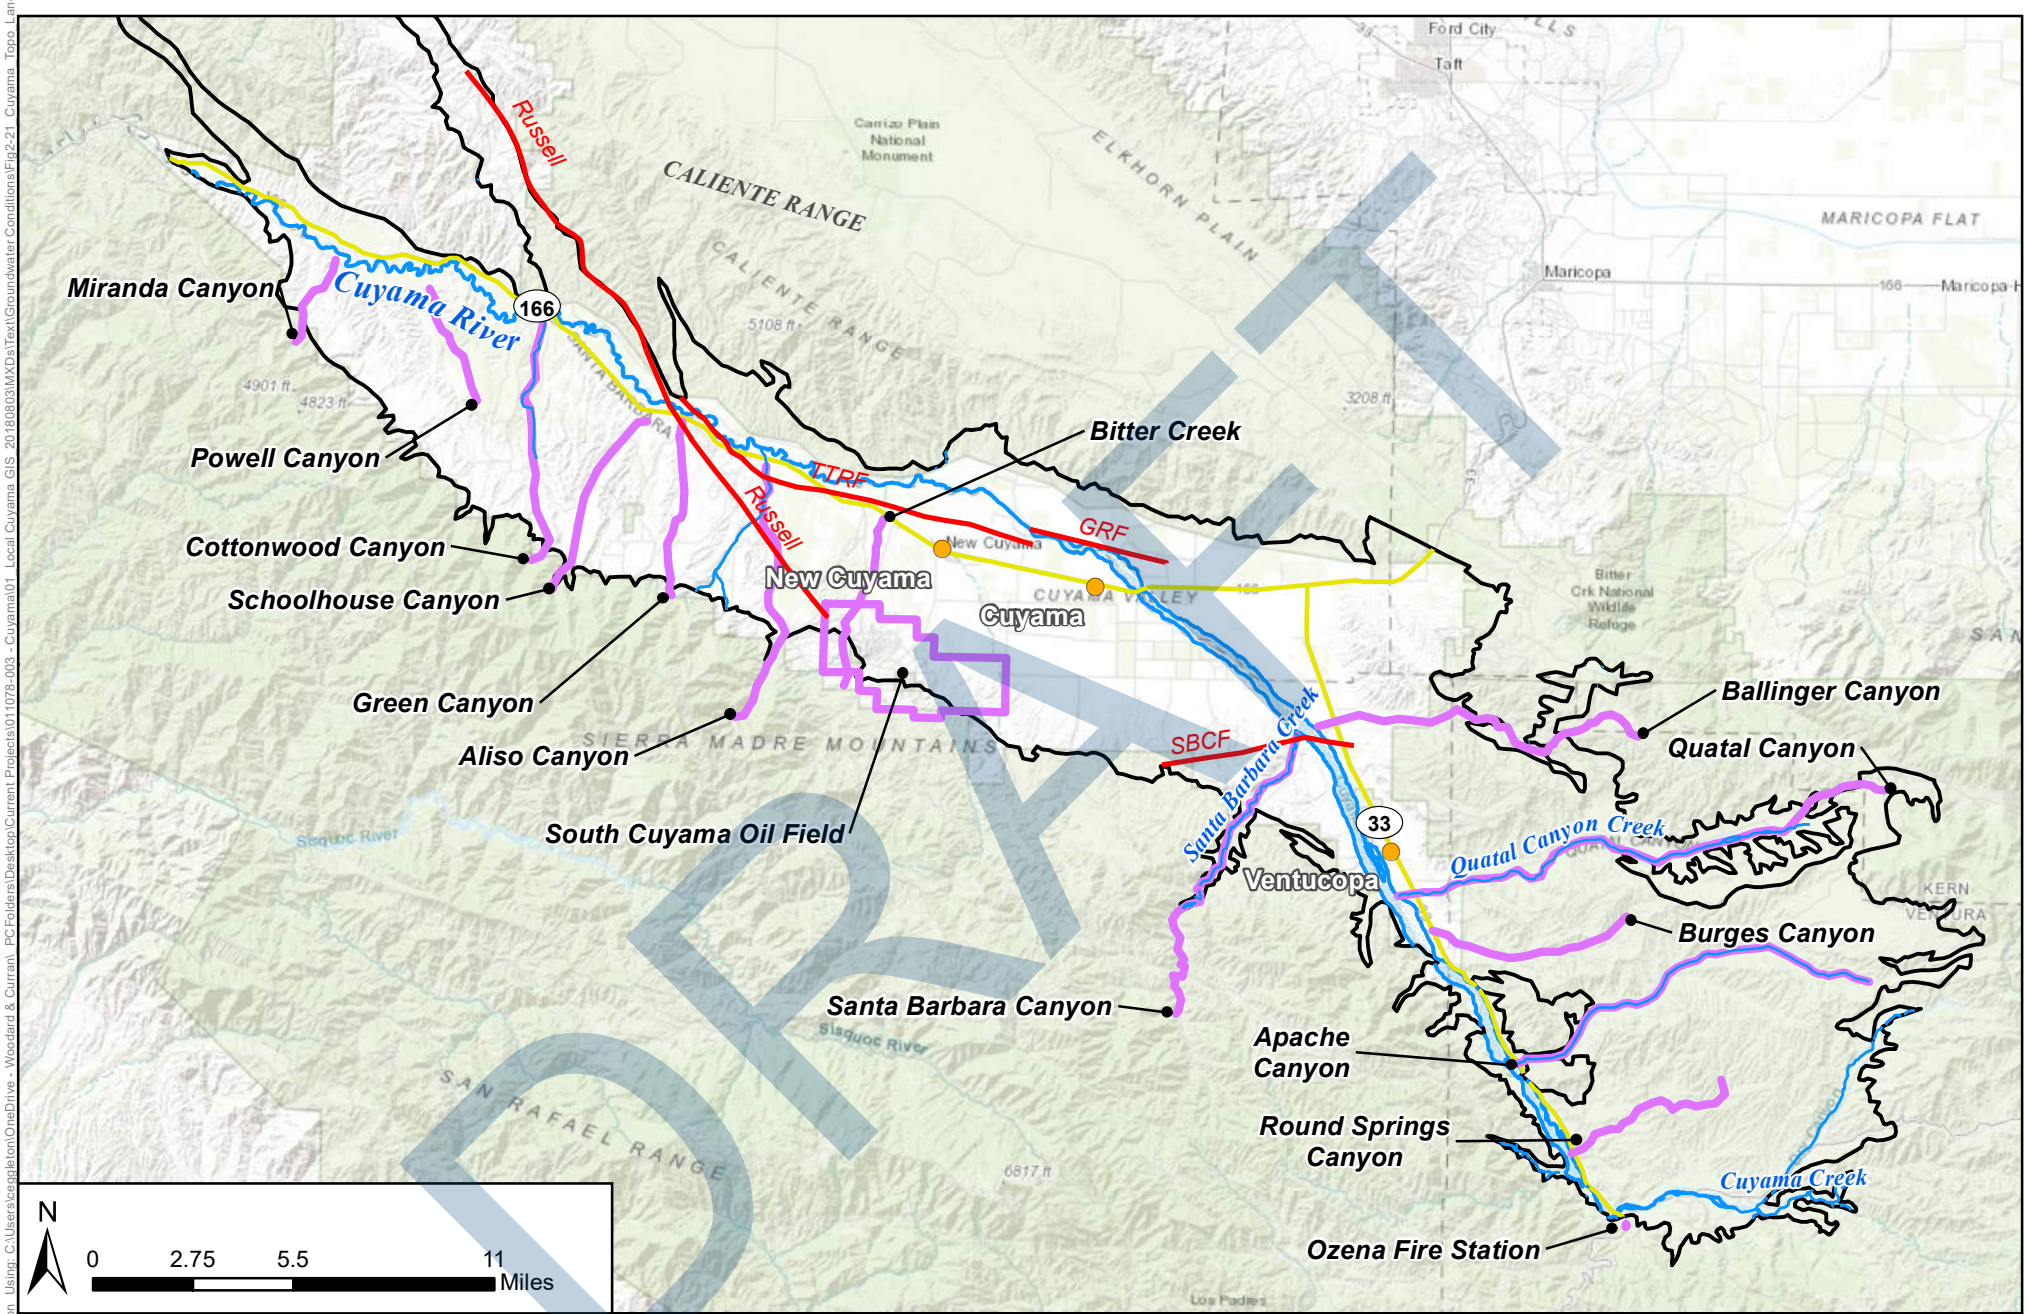
Figure 2-21 - Cuyama Basin Landmarks

Groundwater conditions in the Basin vary by location. To assist in discussion of the location of specific groundwater conditions, Figure 2-21 shows selected landmarks in the Basin to assist discussion of the location of specific groundwater conditions. Figure 2-21 shows major faults in the Basin in red, highways in yellow, towns as orange dots, and canyons and Bitter Creek in purple lines that show their location.

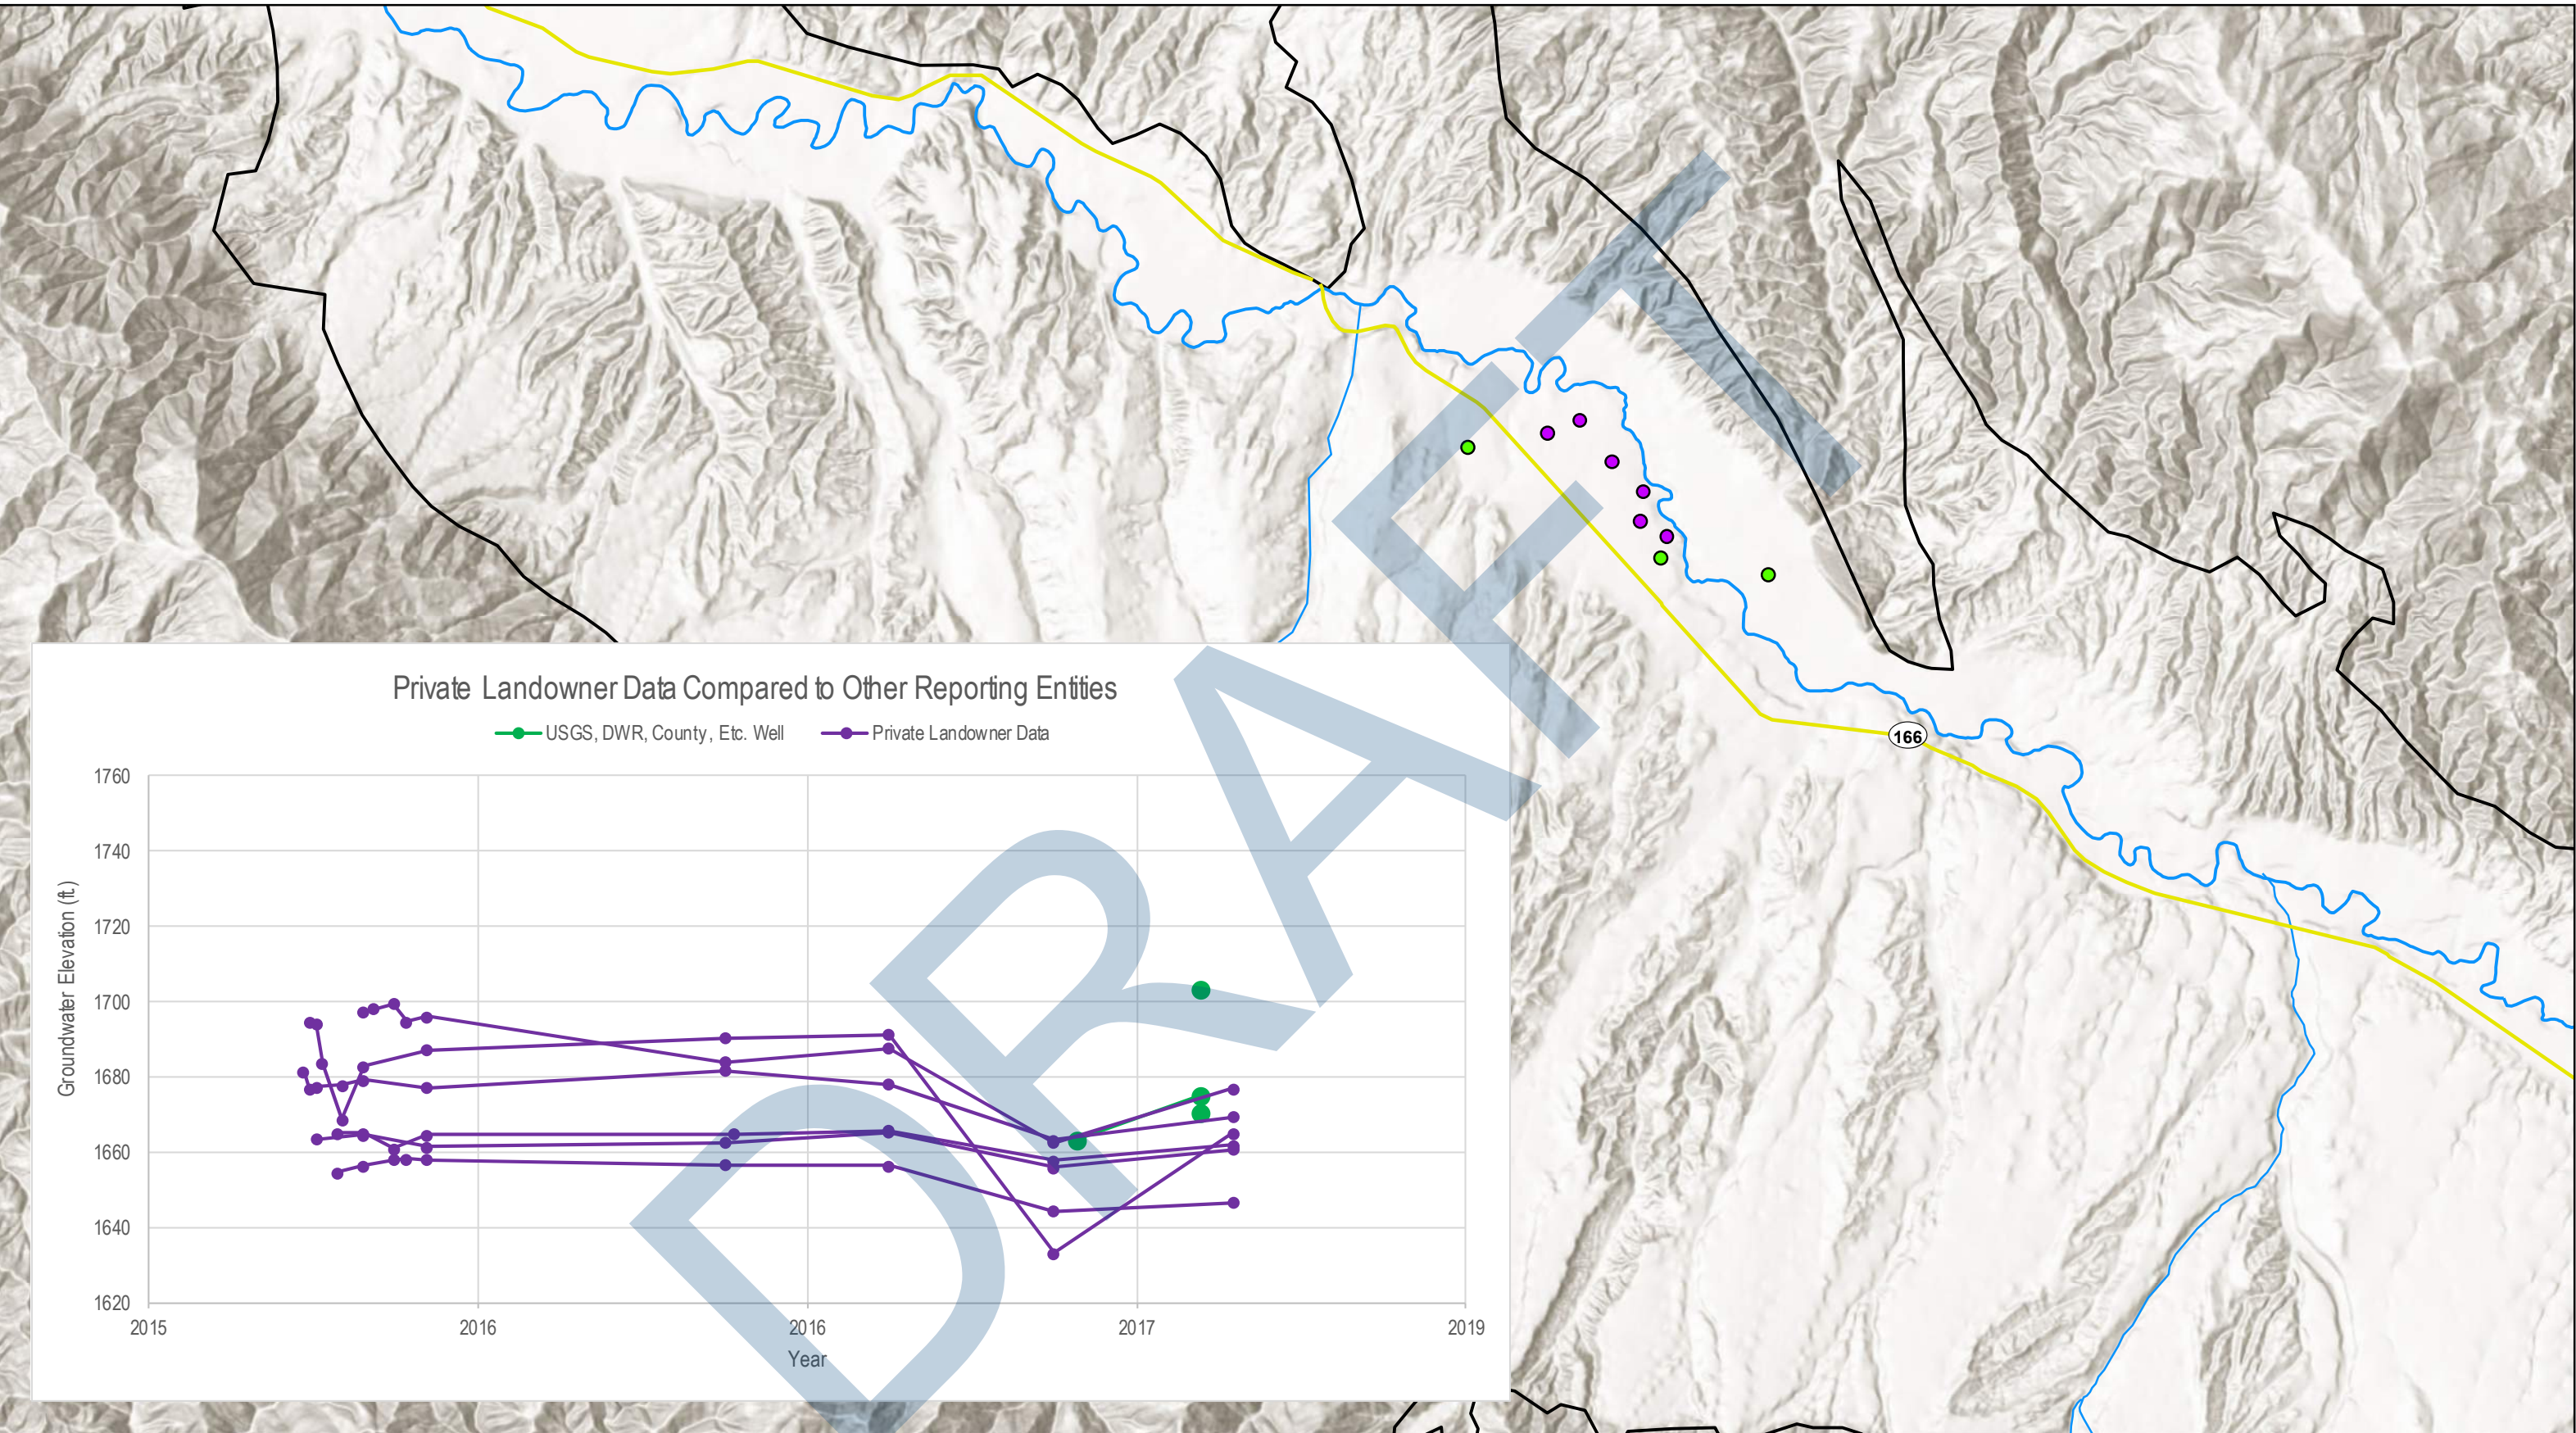
Figure 2-28: Western Cuyama GW Basin Wells and Hydrographs by Data Source

Figure 2-28 shows a comparison of data collected from other private landowners, and data collected from SBCWA. This figure was developed to provide information on the consistency between data from these differing sources. The figure shows the location of compared wells, and the measurements on those wells by source. A long-term comparison is not possible due to the shorter measurement period of the Santa Barbara County wells, but the measurements of groundwater elevation among the measured wells indicate that the monitoring by private landowners in the western portion of the Basin and the county are similar in elevation, with the county's data showing slightly higher elevations.

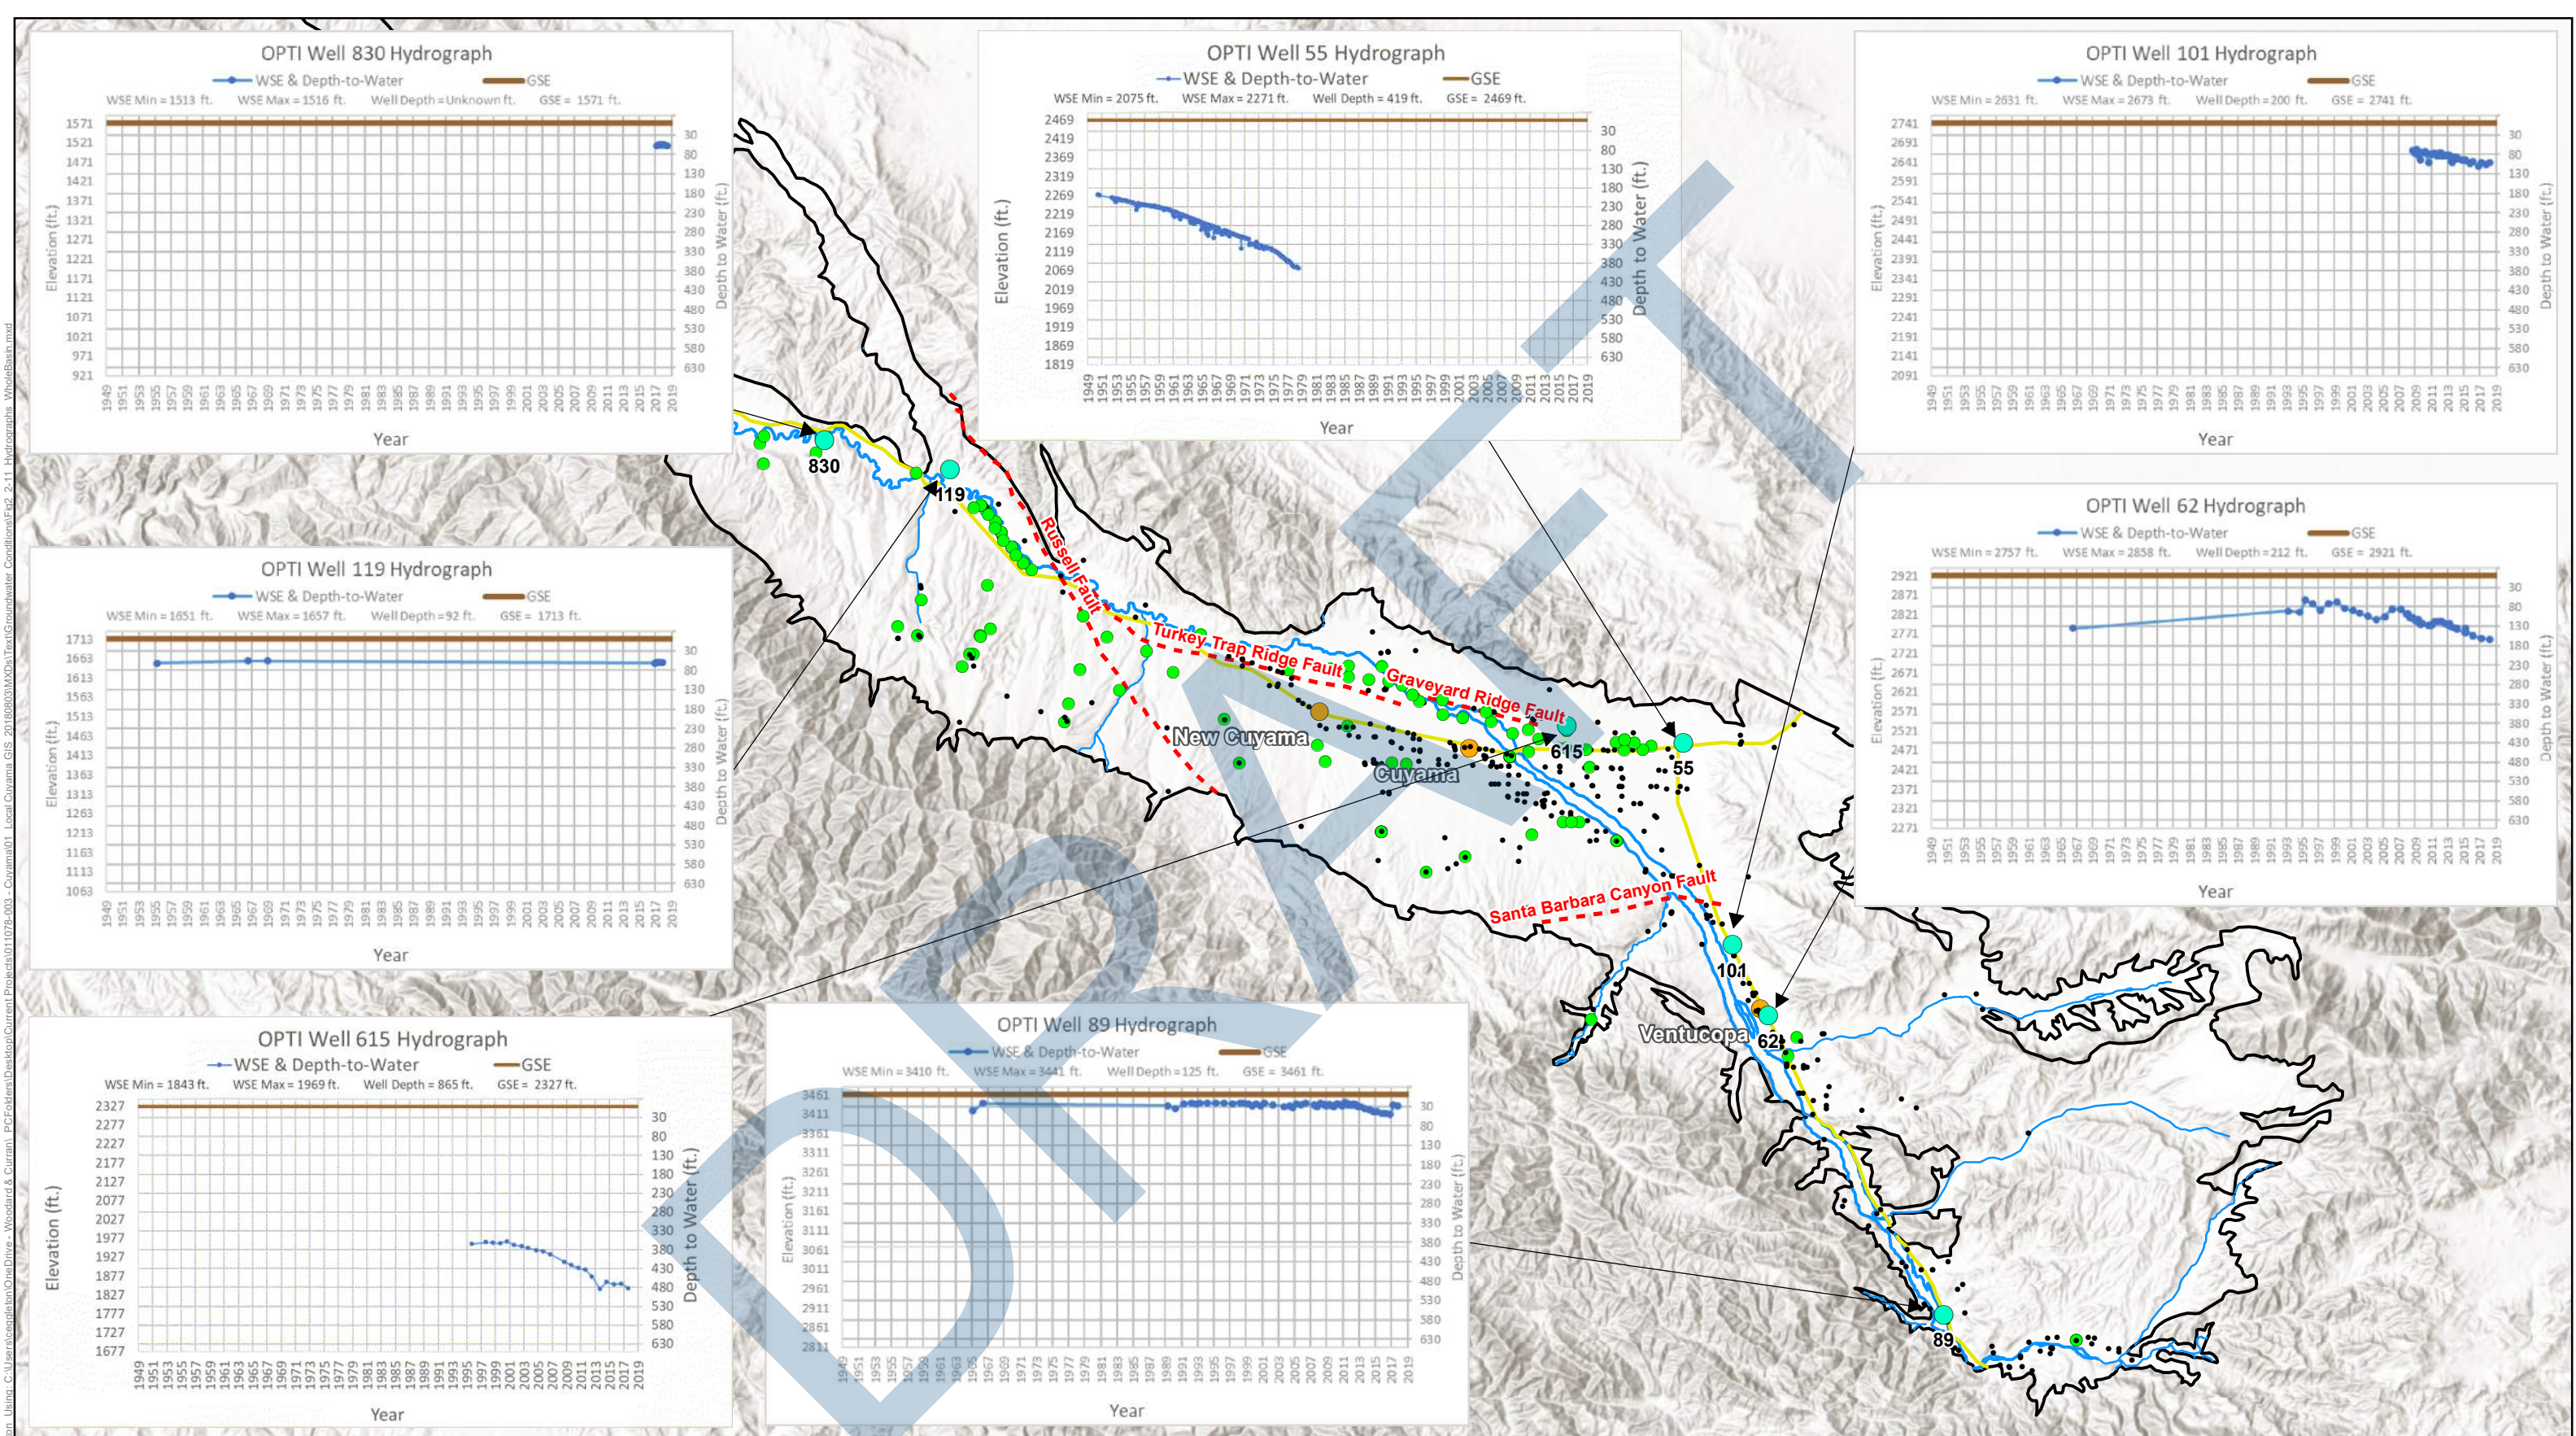
Figure 2-31: Cuyama GW Basin Hydrographs

Groundwater conditions generally vary in different parts of the Basin. Figure 2-31 shows hydrographs in select wells in different portions of the Basin. These wells were selected they broadly represent Basin conditions in their areas. More information about conditions is below.

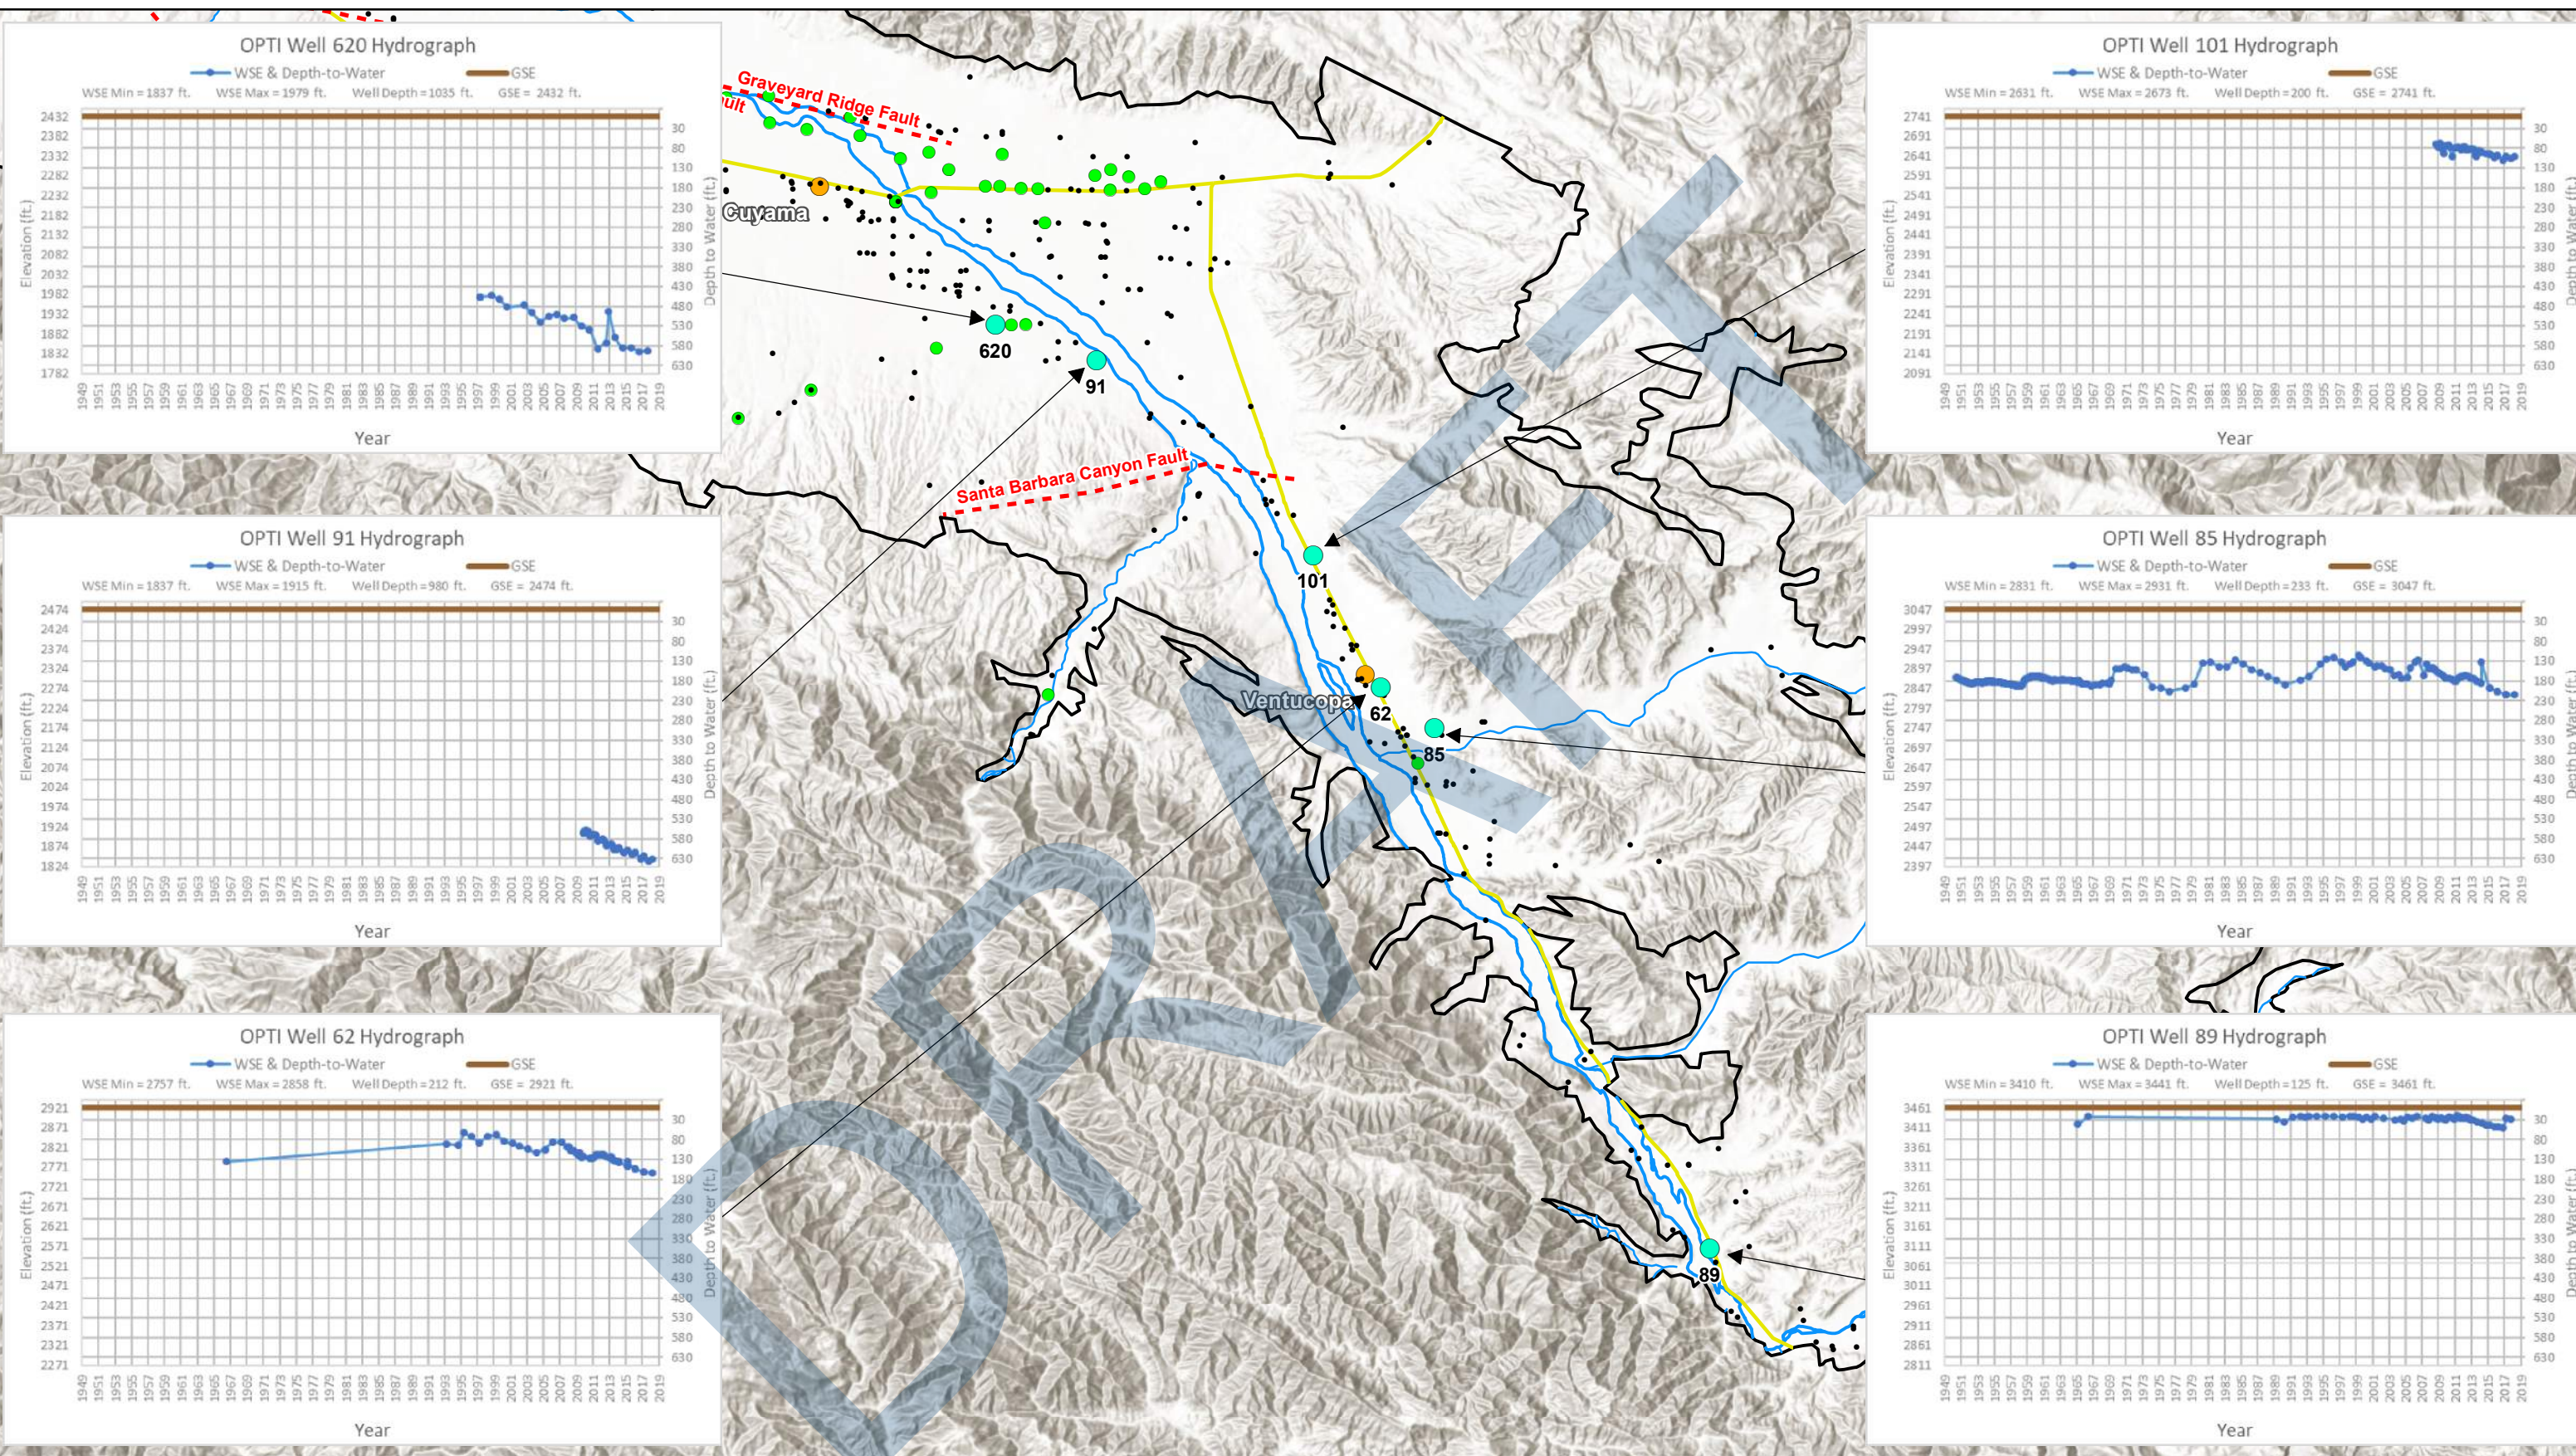
Figure 2-32: Cuyama GW Basin Hydrographs for the Ventucopa Area of the Basin
 Cuyama Basin Groundwater Sustainability Agency
 Cuyama Valley Groundwater Basin Groundwater Sustainability Plan
 April 2019

Figure 2-32 shows selected hydrographs for wells in the area near Ventucopa. Near Ventucopa, hydrographs for Wells 85 and 62 show the same patterns and conditions from 1995 to the present and show that groundwater levels in this area respond to climactic patterns, but also have been in decline since 1995 and are currently at historic low elevations. The hydrograph for Well 85 shows that prior to 1985 groundwater levels responded to drought conditions but recovered during wetter years. Well 40 is located just south of the SBCF and its hydrograph indicates that groundwater levels in this location have remained stable from 1951 to 2013, when monitoring ceased. Wells 91 and 620 are north of the SBCF and their hydrographs show more recent conditions, where depth to water has declined consistently and is below 580 feet below ground surface (bgs).
