2. BASIN SETTINGS: OVERVIEW

2.1 Basin Settings: HCM

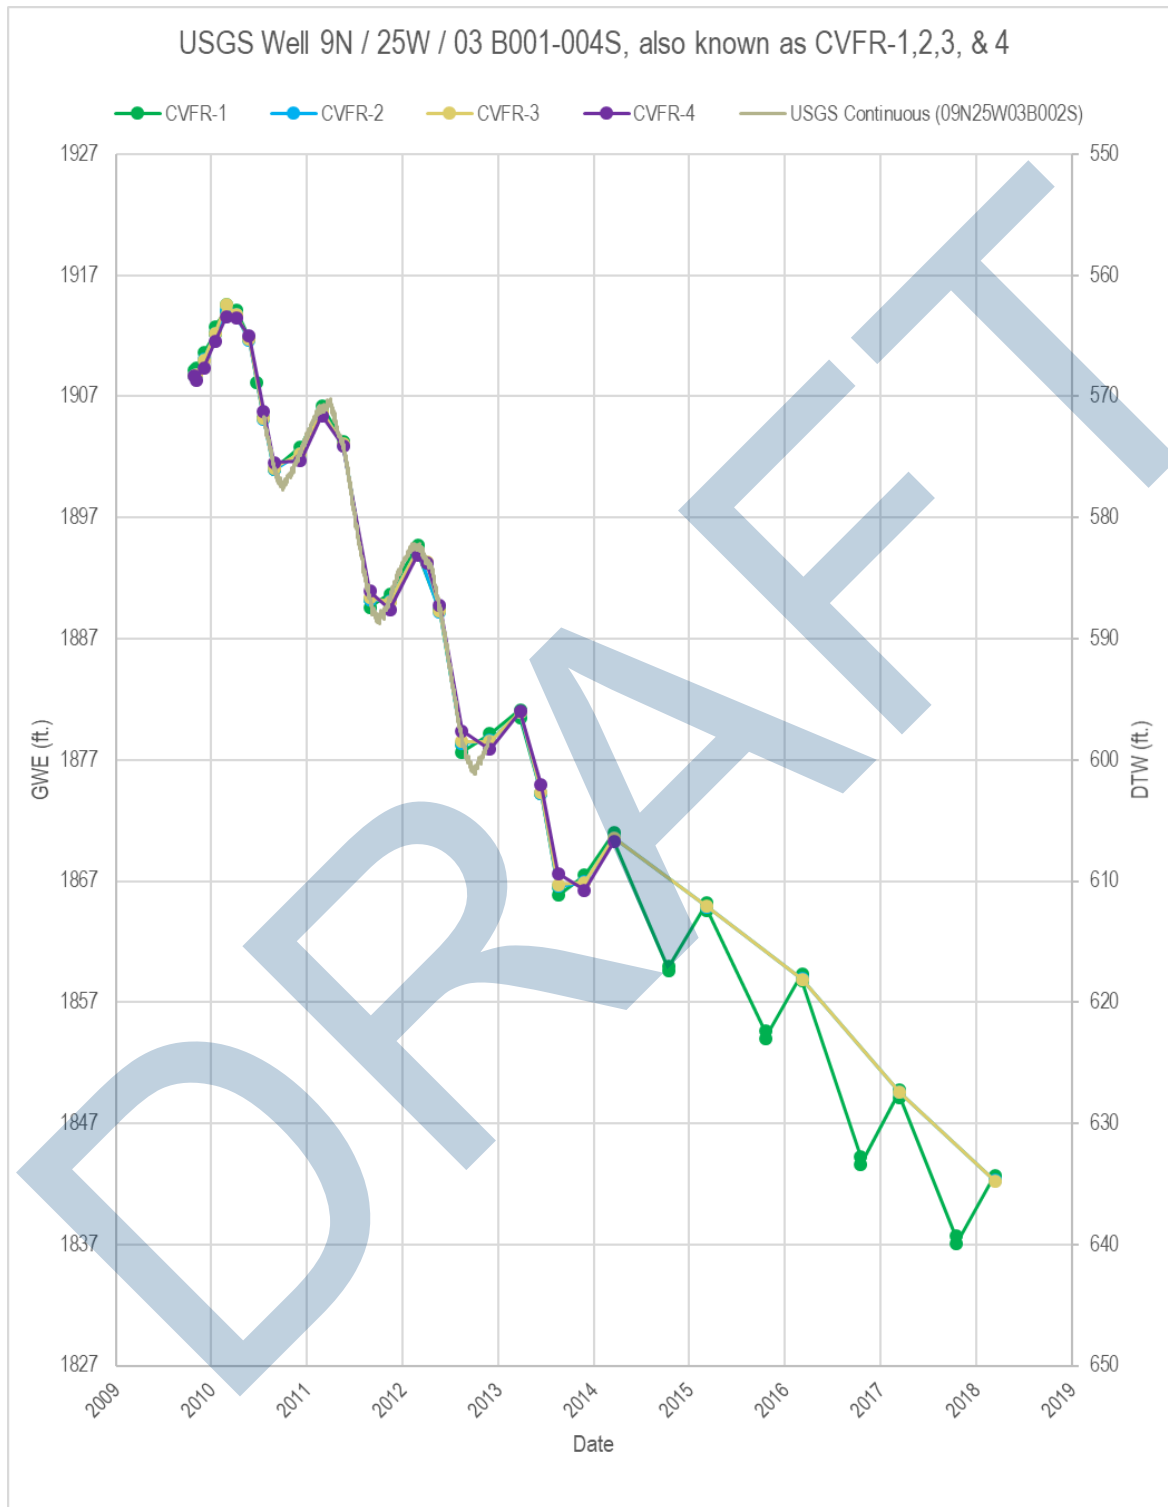
Figure 2-36: Hydrographs of CVFR1-4

The hydrograph of the four completions shows that at the deeper completions, groundwater elevations are slightly lower than the shallower completions in the winter and spring, and deeper completions are generally lower than the shallower completion in the summer and fall. This indicates that during the irrigation season, the deeper portions of the aquifer are likely to be where pumping occurs. This pumping removes water from the deeper portion of the aquifer, creating a vertical gradient during the summer and fall. By the spring, enough water has moved down or horizontally to replace removed water, and the vertical gradient is significantly smaller at this location in the spring measurements.

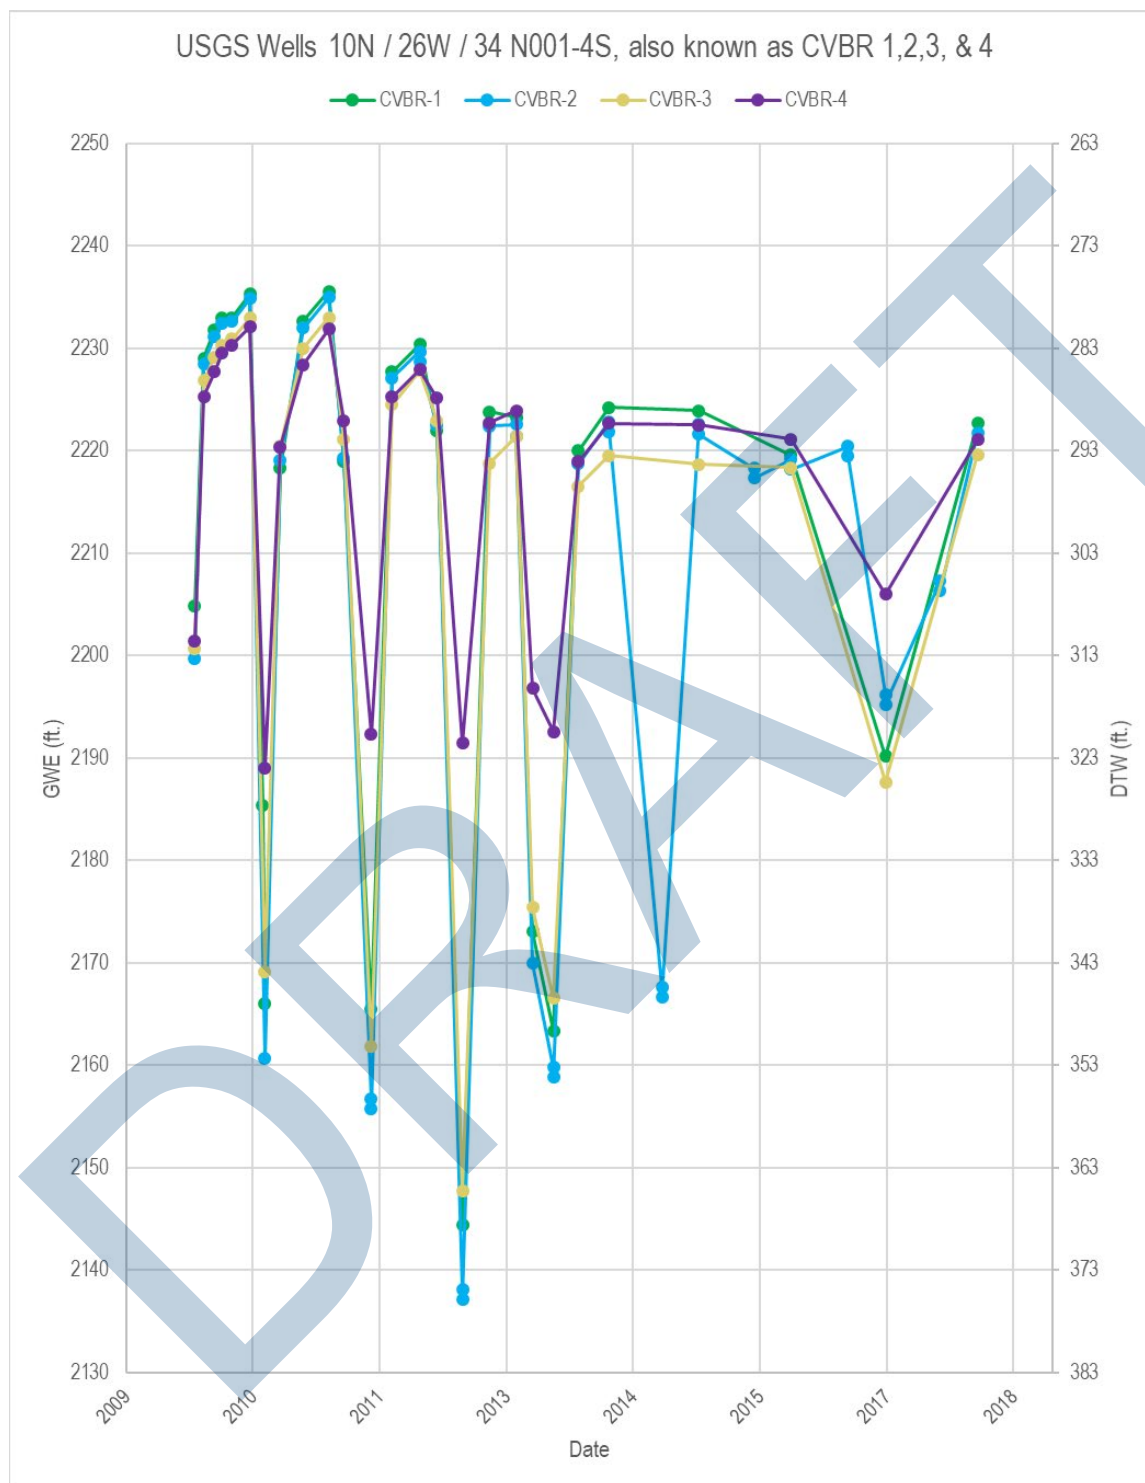
Figure 2-37: Hydrographs of CVBR1-4

The hydrograph of the four completions shows that at the deeper completions are slightly lower than the shallower completions in the spring at each completion, and deeper completions are generally lower in the summer and fall. This indicates that during the irrigation season, the deeper portions of the aquifer are likely to be where pumping occurs. This pumping removes water from the deeper portion of the aquifer, creating a vertical gradient during the summer and fall. By the winter and spring, enough water has moved down to replace removed water, and the vertical gradient is very small at this location in the spring measurements.

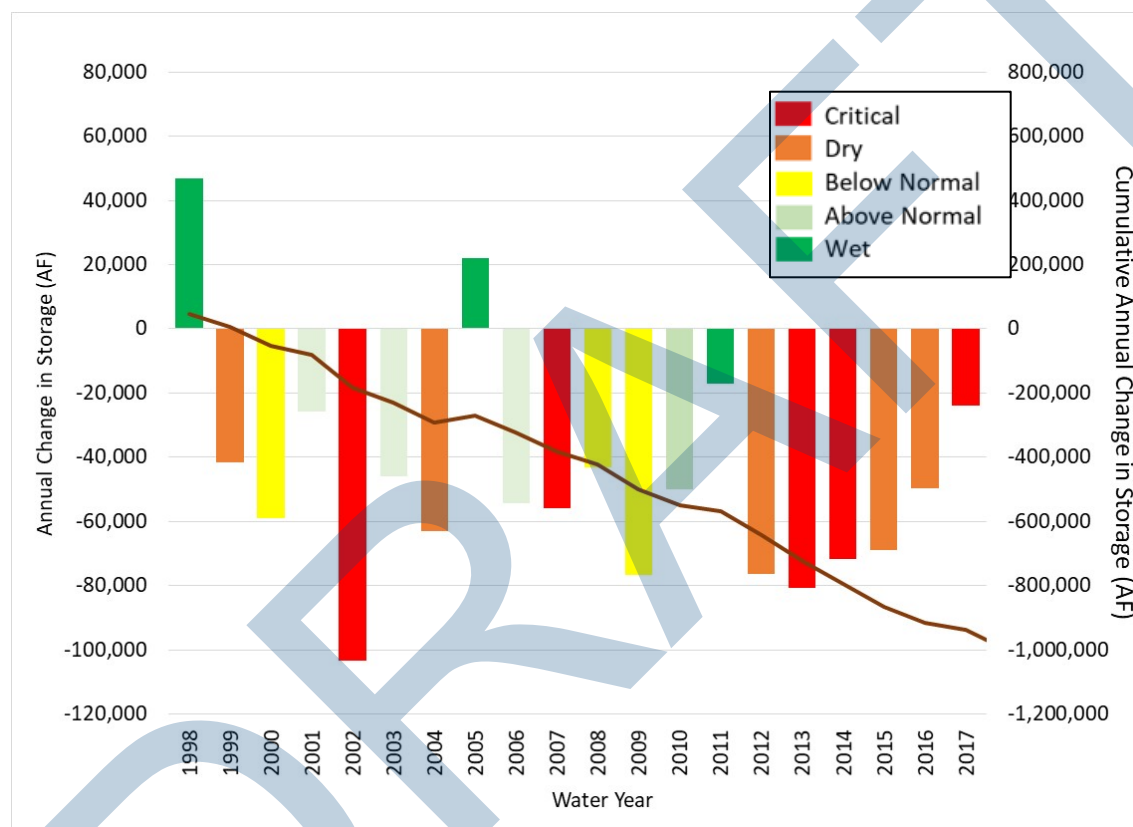
Figure 2-49: Cuyama Groundwater Storage by Year, Water Year Type, and Cumulative Water Volume

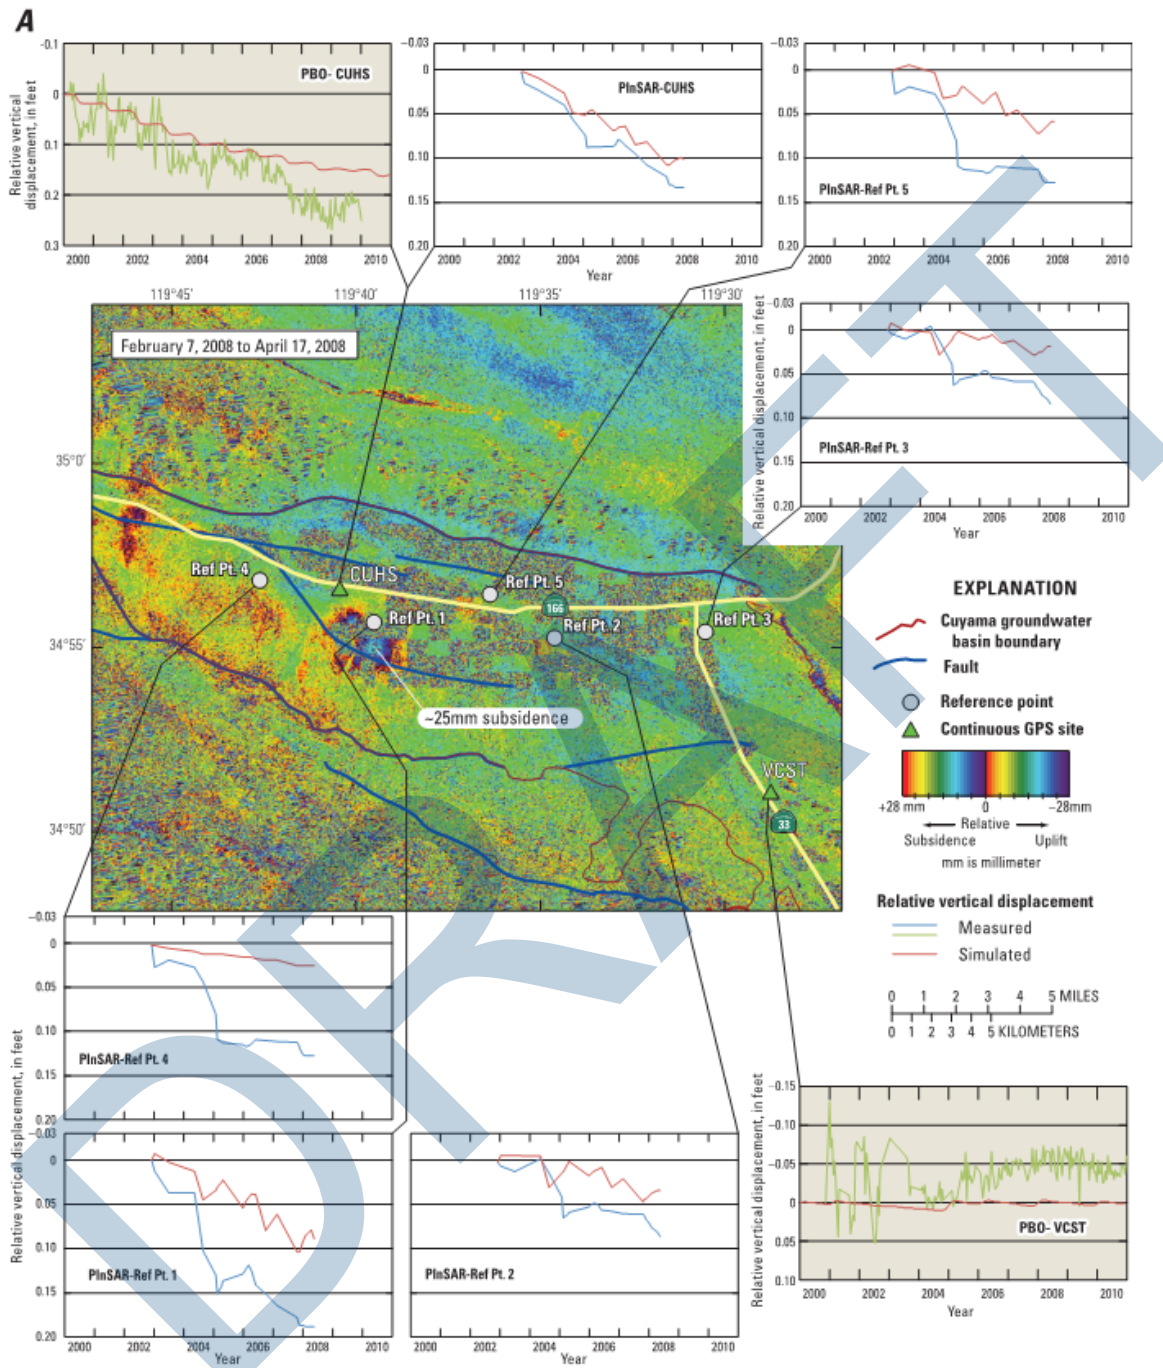
Figure 29. Historical subsidence as A, map of seasonal InSAR with graphs of simulated and measured time series for selected locations of relative land-surface deformation from Plate-Boundary Observation (PBO) sites and Point InSAR targets, and B, simulated total subsidence 1950–2010 for the calibrated hydrologic flow model, Cuyama Valley, California.
